Busby's Bore Archaeology Report

**OPTIONS FOR THE PROTECTION AND INTERPRETATION OF
UNDERGROUND ARCHAEOLOGICAL REMAINS FROM BUSBY'S BORE**

11 DRIVER AVE, MOORE PARK

Date
08/07/25

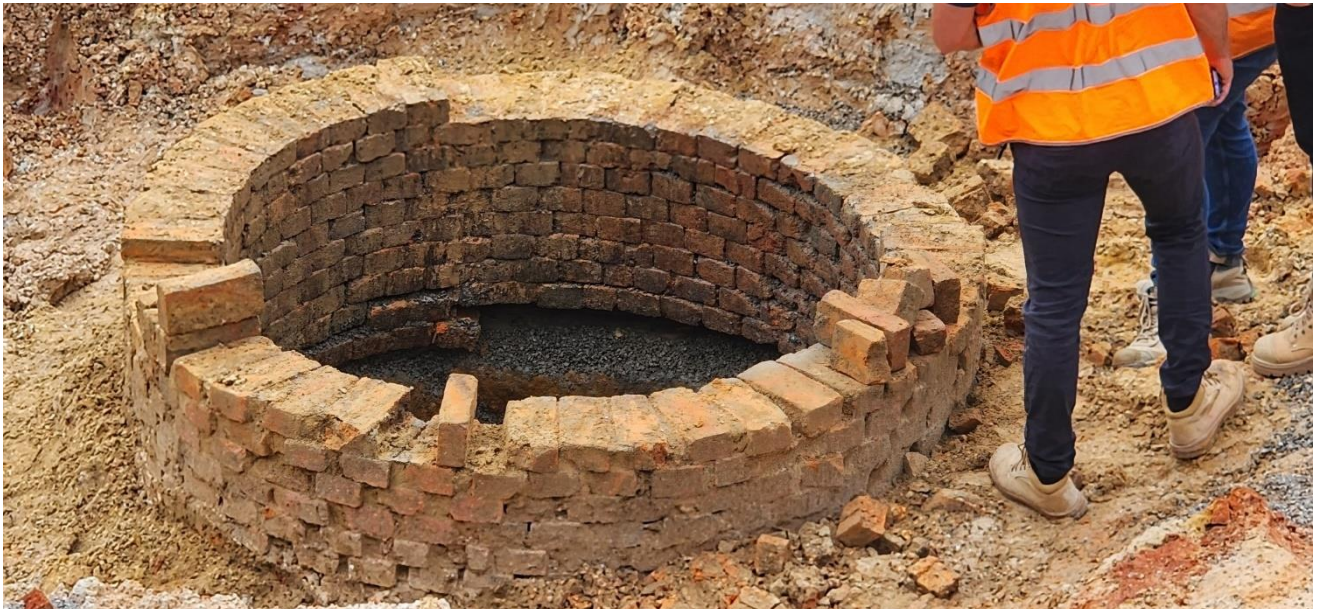
The brickwork was laid in a radial format with the short end forming the inner face of the shaft. Each course consisted of approximately 45 bricks.

Plate 2: Image of shaft during excavation. Note the radial layout of the brickwork with the outward gaps filled with possibly a soft mortar / clay. The horizontal joints are very thin.

- The brickwork should be laid in a radial format to match the diameter of the original shaft, refer to Plate 2. The brick courses should use a comparable number of bricks as the original configuration (app 45 bricks per course).
- The triangular voids to the rear of each course should be filled using a very soft lime mortar to provide stability to each course.
- The lowest part course of the stonework overlaps the upper layers of brickwork (refer Plate 3). The stone displaying the Government Arrow carving should be displayed to enhance the storytelling potential of the reconstructed remains.

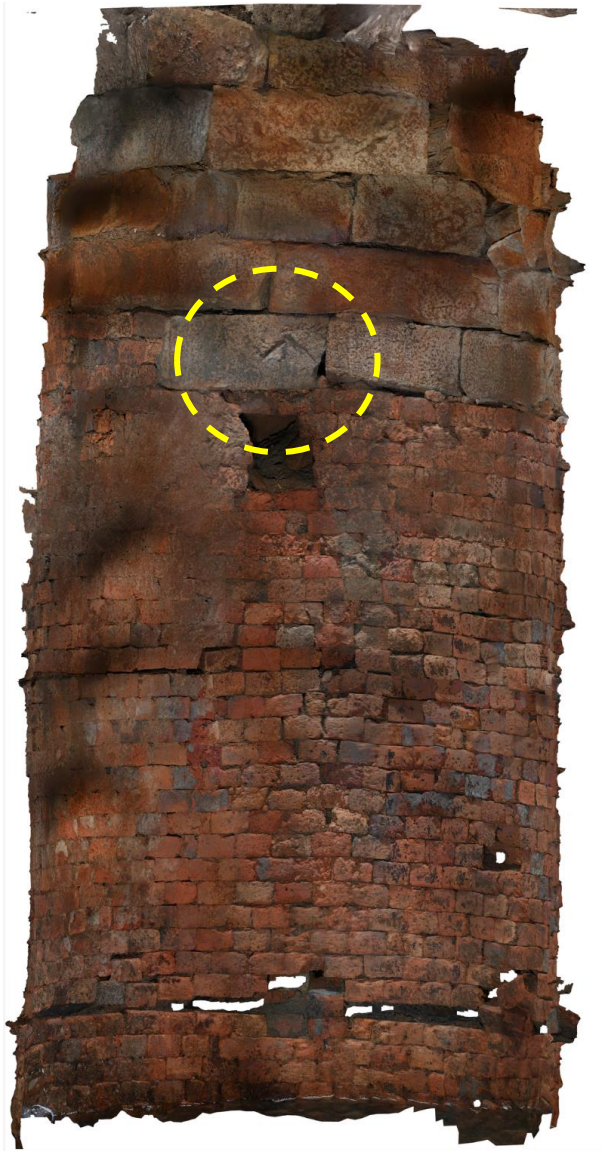
The photogrammetry supplied by Artefact shows that the lowest of the five/six courses of stone overlaps the upper courses of the brickwork. This stone also shows clear evidence of the Government issue arrow.

Plate 3: Interior photogrammetry of the shaft. Note the Government arrow on the inside face of the lowest course of the stonework.

- We recommend that stainless steel brick ties are discretely inserted to tie the brick cylinder to the surrounding new concrete structure.
- The upper three courses of the brickwork should be rebuilt to accommodate the stone that shows the arrow on the inner face. One or more full courses of stone could be laid above this part course.
- The stone is significantly wider than the brick wall below and may require additional masonry buttressing to provide adequate bearing and support.

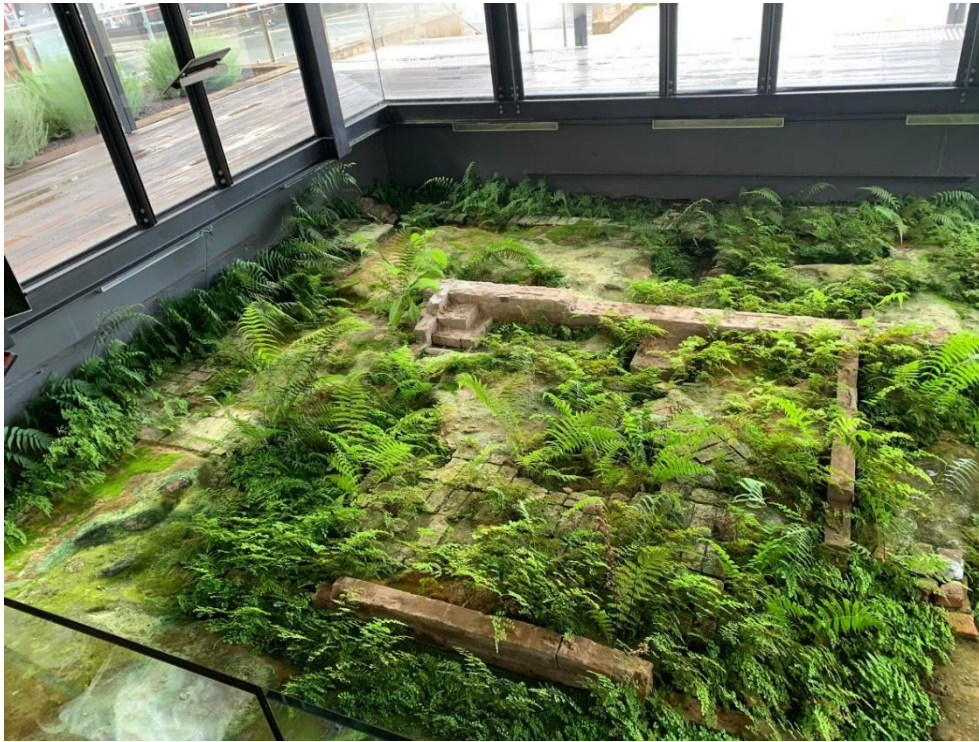
Due to the combination of moisture build-up and light, the Hospital Pavilion develops excessive biological growth on the archaeological remains (including ferns, moss, and mould, which required ongoing maintenance) as well as mould on interior surfaces of the building. The Kitchen Pavilion also exhibits biological growth but, more significantly, is affected by salt efflorescence, which has resulted in powdering and spalling of the excavated stonework.

Plate 4: Parramatta Justice Precinct – Hospital Pavilion, showing biological growth obscuring remains

While installation of additional passive and mechanical ventilation may slightly reduce the amount of moisture within the spaces, the close proximity of the water table means that the remains will always be wet and will be subject to ongoing deterioration even if interventions are made on the pavilions.

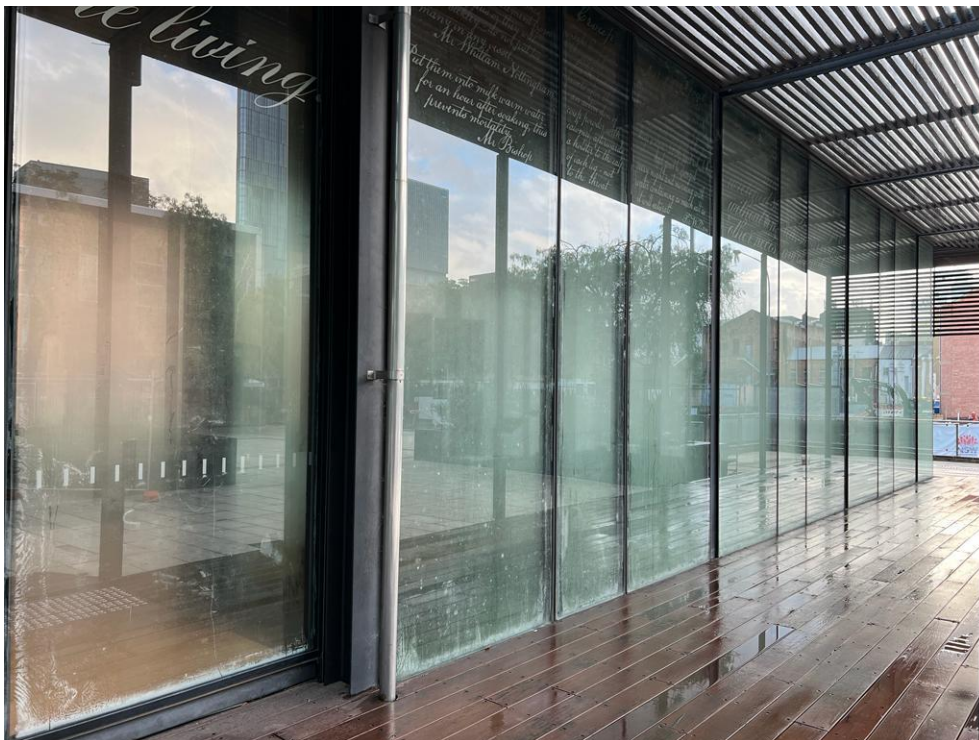
Plate 5: Parramatta Justice Precinct – Hospital Pavilion, showing condensation on glass from high humidity and lack of ventilation

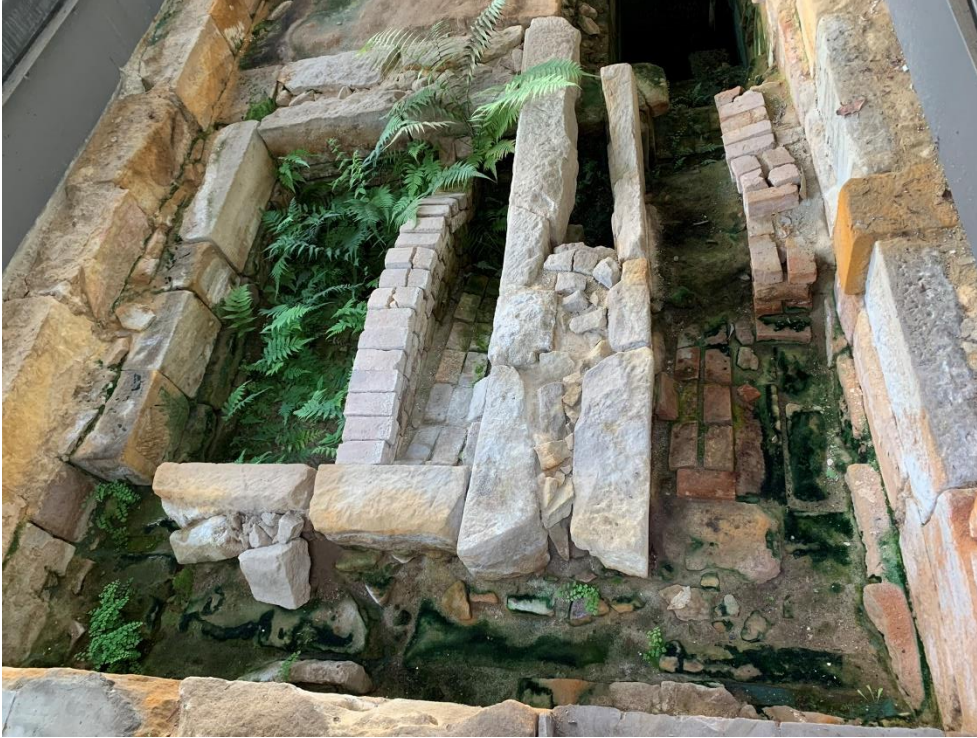
Plate 6: Parramatta Justice Precinct- Kitchen Pavilion, showing biological growth

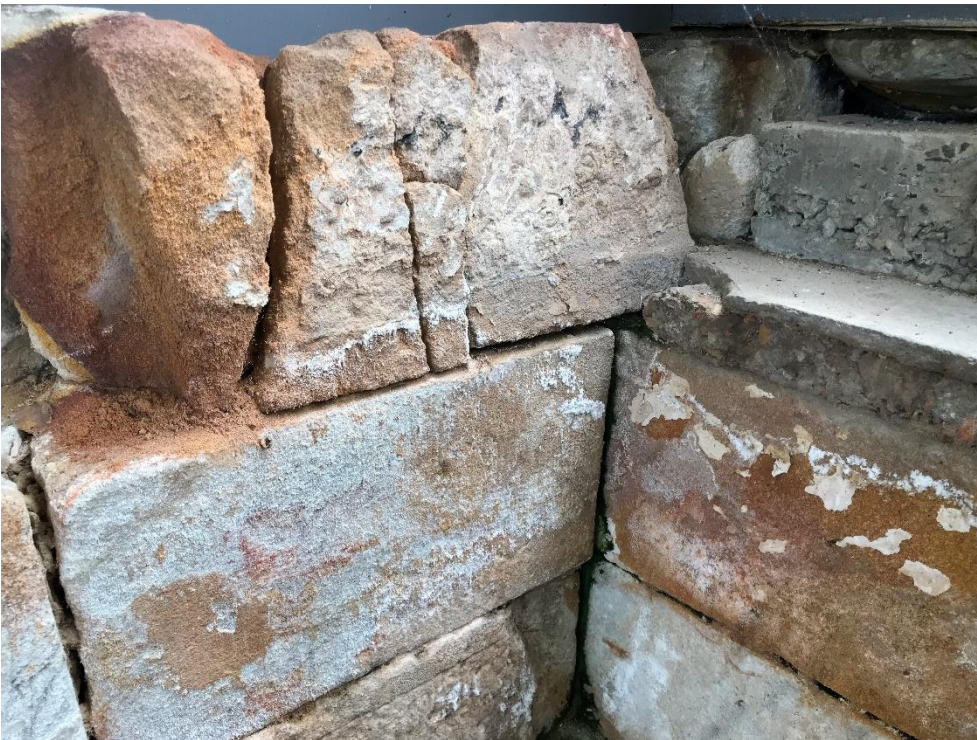
Plate 7: Parramatta Justice Precinct - Kitchen Pavilion, showing damage from soluble salt efflorescence

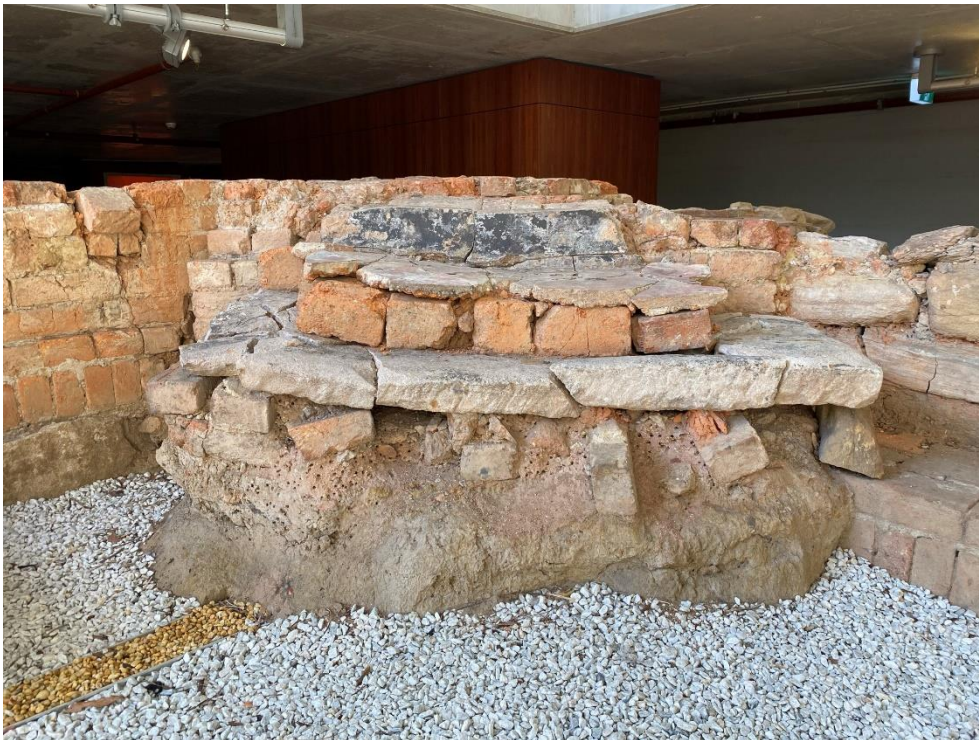
While the fully open display allows for increased airflow, it has also led to infestation of the site by a species of native wasps that burrow into the soft mortar between the bricks and jeopardises their structural integrity.

Plate 9: Early convict settlement at V by Crown, Parramatta – showing damage to mortar by native wasps

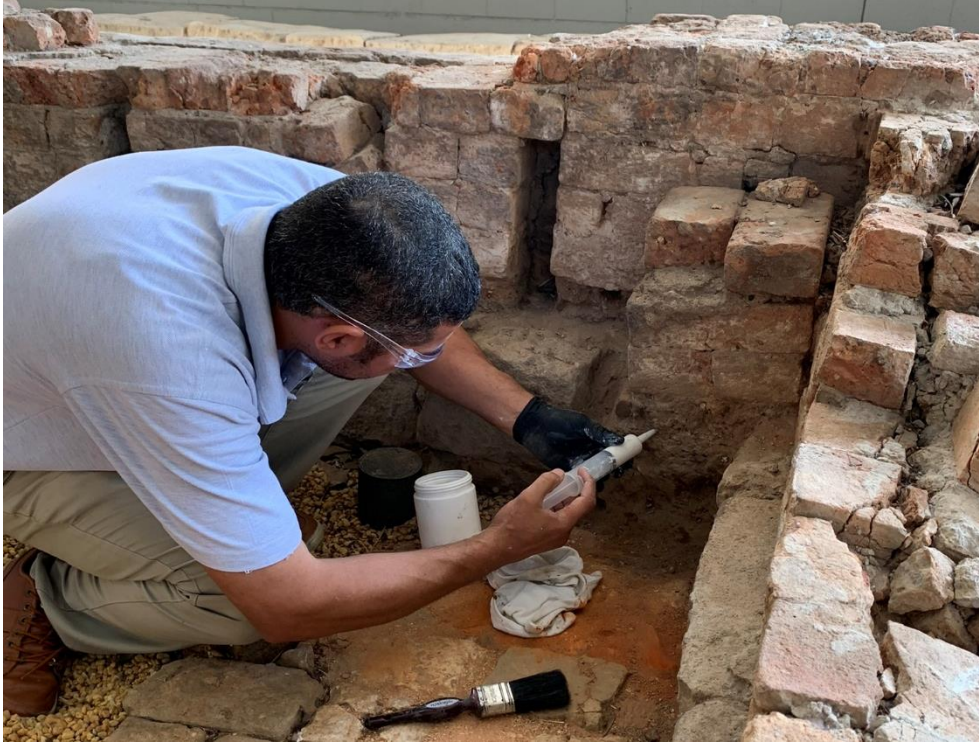
Plate 10: Early convict settlement at V by Crown, Parramatta – showing repair of wasp burrows

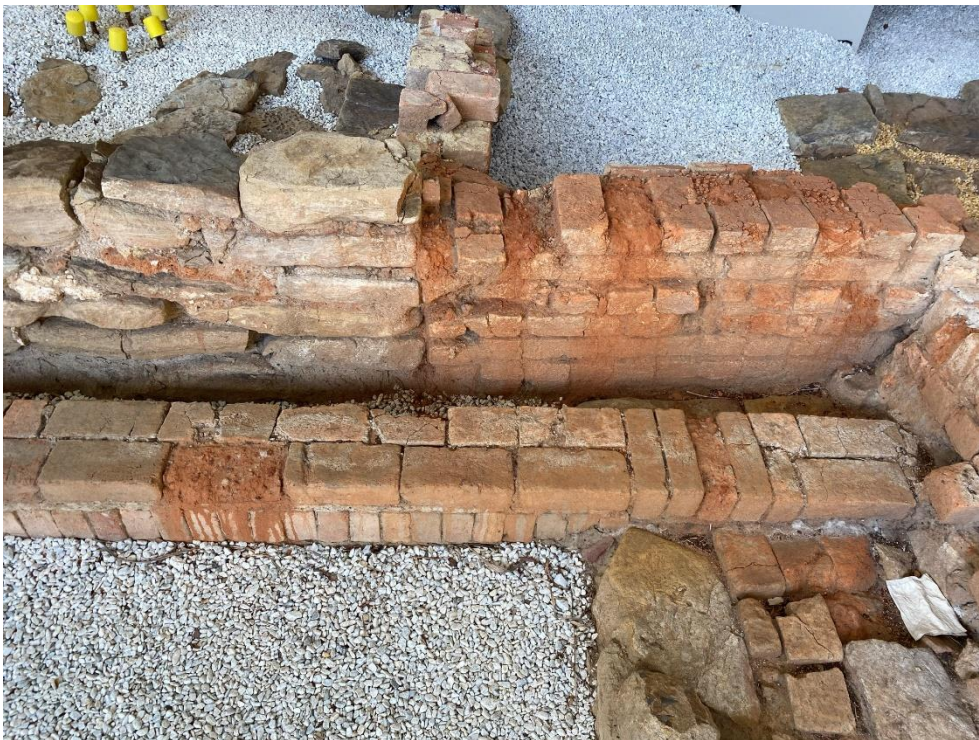
Plate 11: Early convict settlement at V by Crown, Parramatta – showing erosion from water ingress

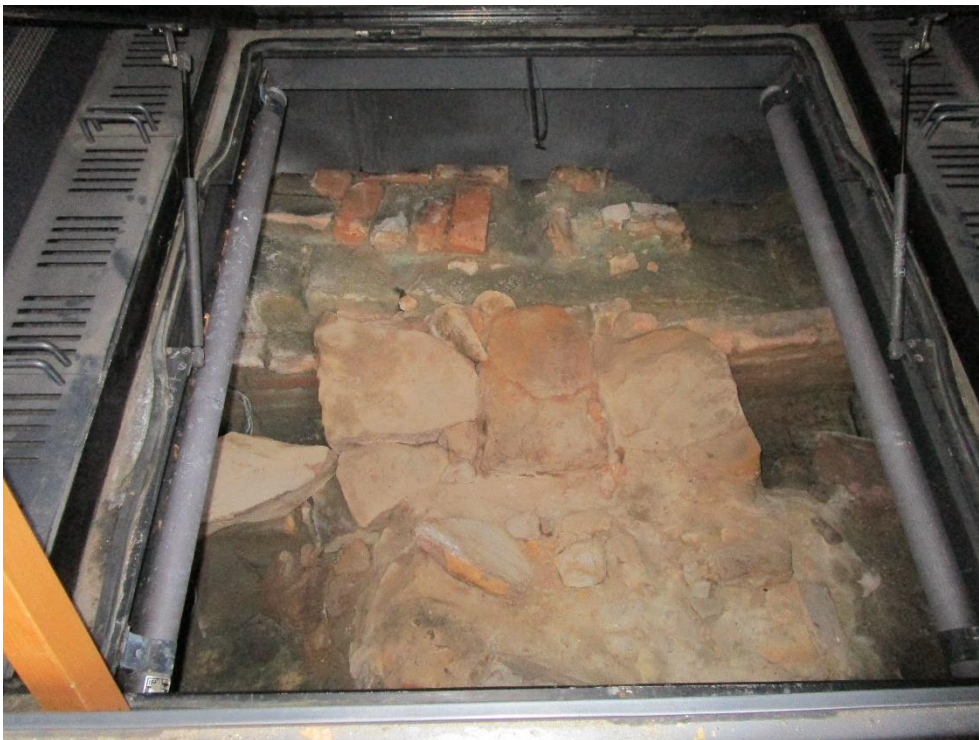
While not to the same extent as the Parramatta Hospital site, the First Government House remains continue to exhibit algal growth and salt efflorescence degradation associated with the presence of moisture and light. The site is also prone to build-up of detritus, including dead insects, degraded builders' plastic and dust, which requires ongoing maintenance.

Plate 13: First Government House at Museum of Sydney – view within one of the windows, showing development of green/grey biological growth along top

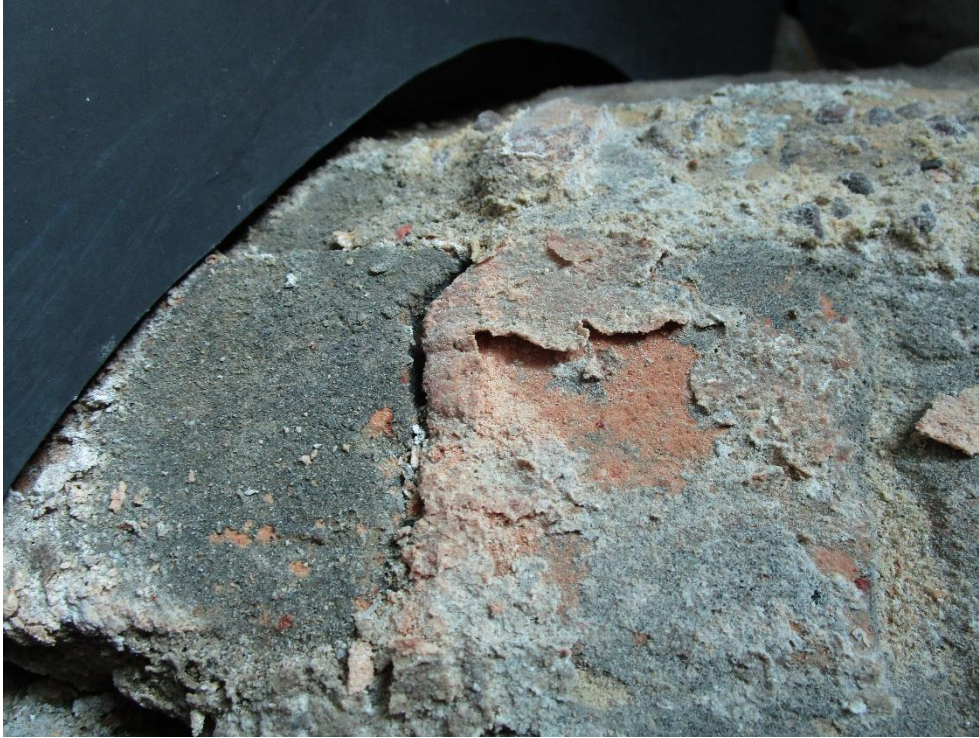
Plate 14: First Government House at Museum of Sydney –showing development of salt efflorescence 'crust' and associated damage from detachment

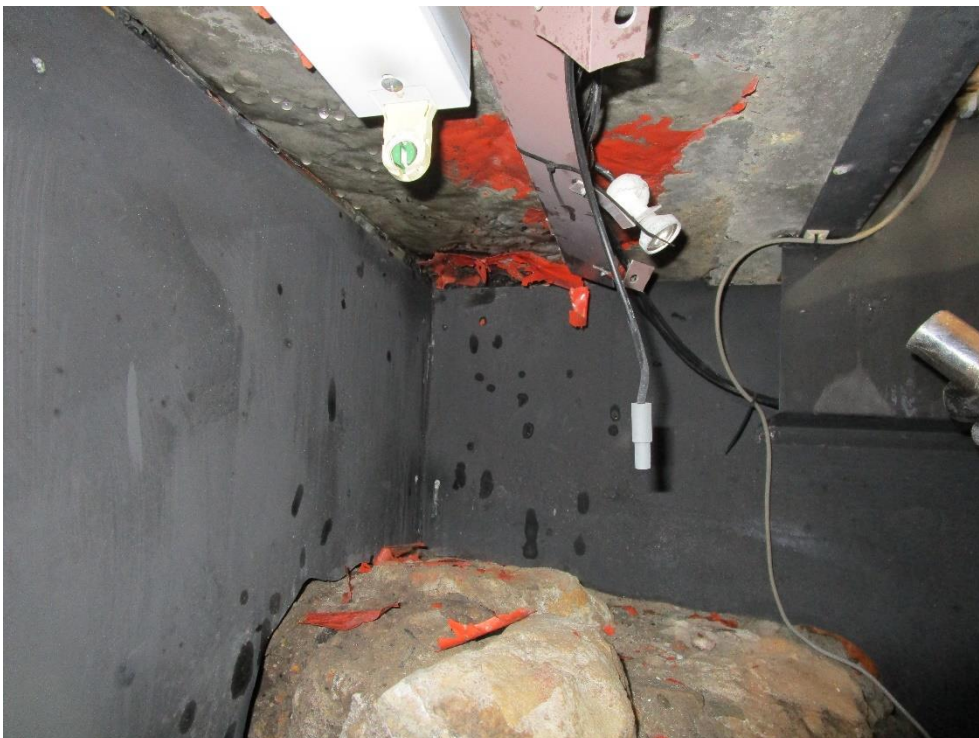
Plate 15: First Government House at Museum of Sydney –showing dripping of water onto archaeological remains and deterioration of building plastics
