Report on  
Preliminary Site Investigation (Contamination)

Barangaroo Station Construct Only Package  
Hickson Road, Barangaroo

Prepared for  
Watpac Construction Pty Ltd

Project 209150.00  
November 2021

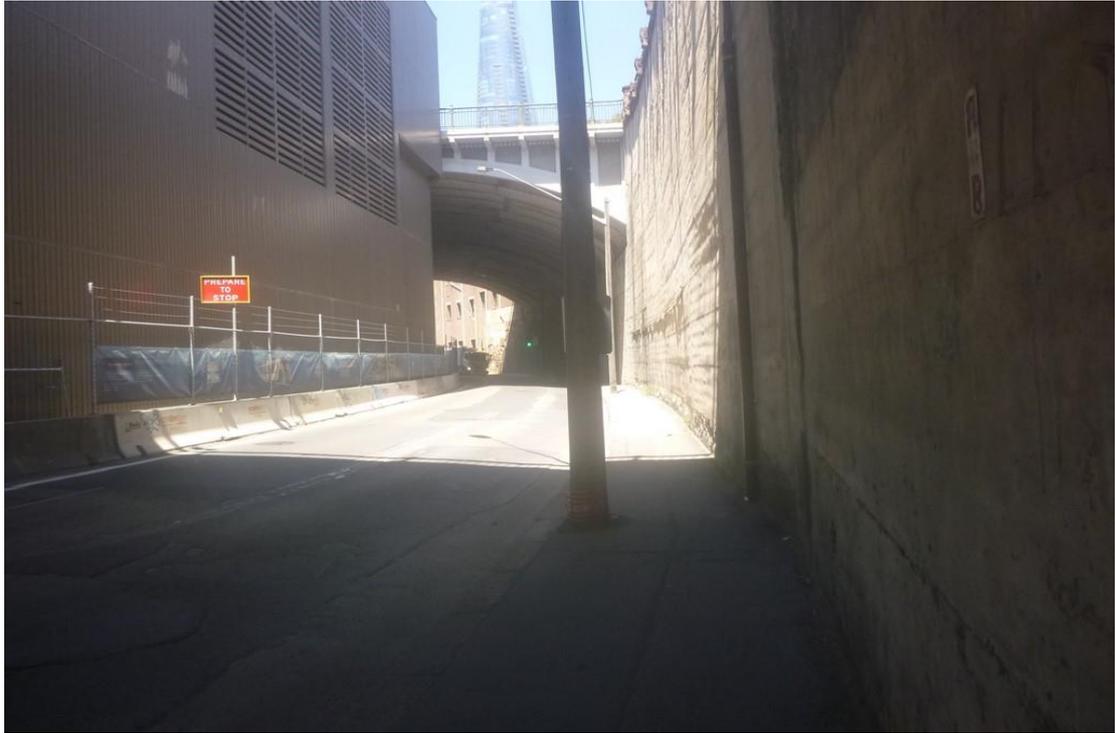
Photograph 1 - Northern end of site (Hickson Road)

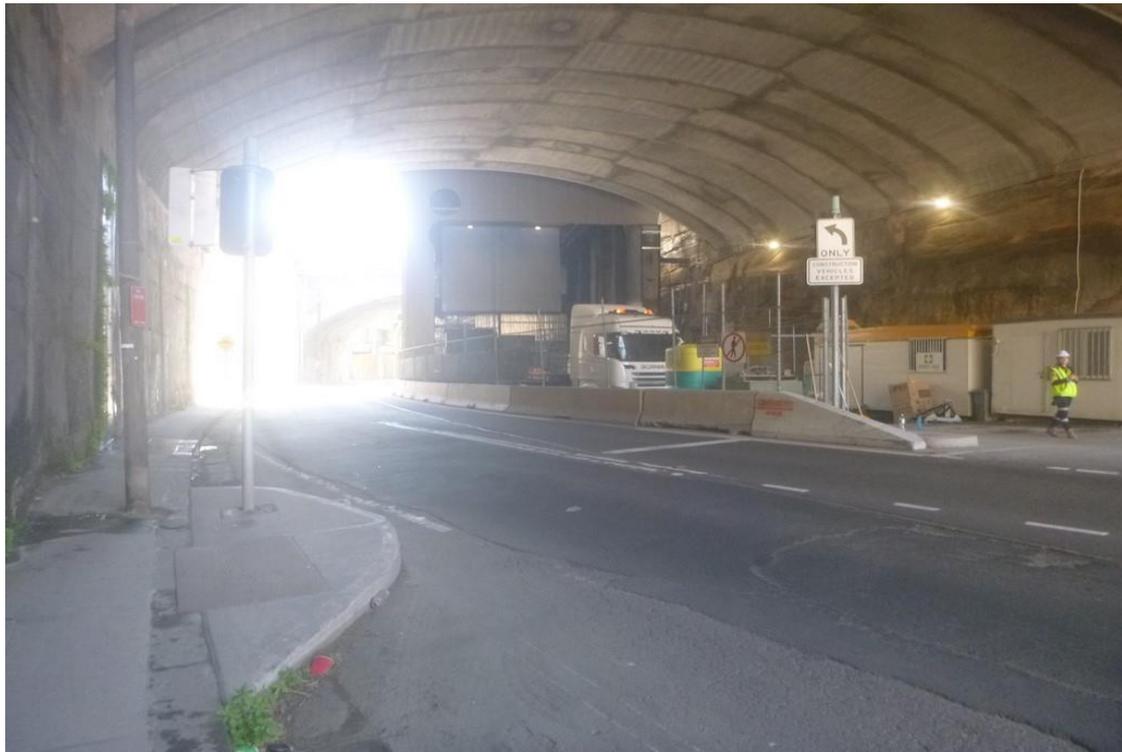
Photograph 2 - Northern end of site (Hickson Road)

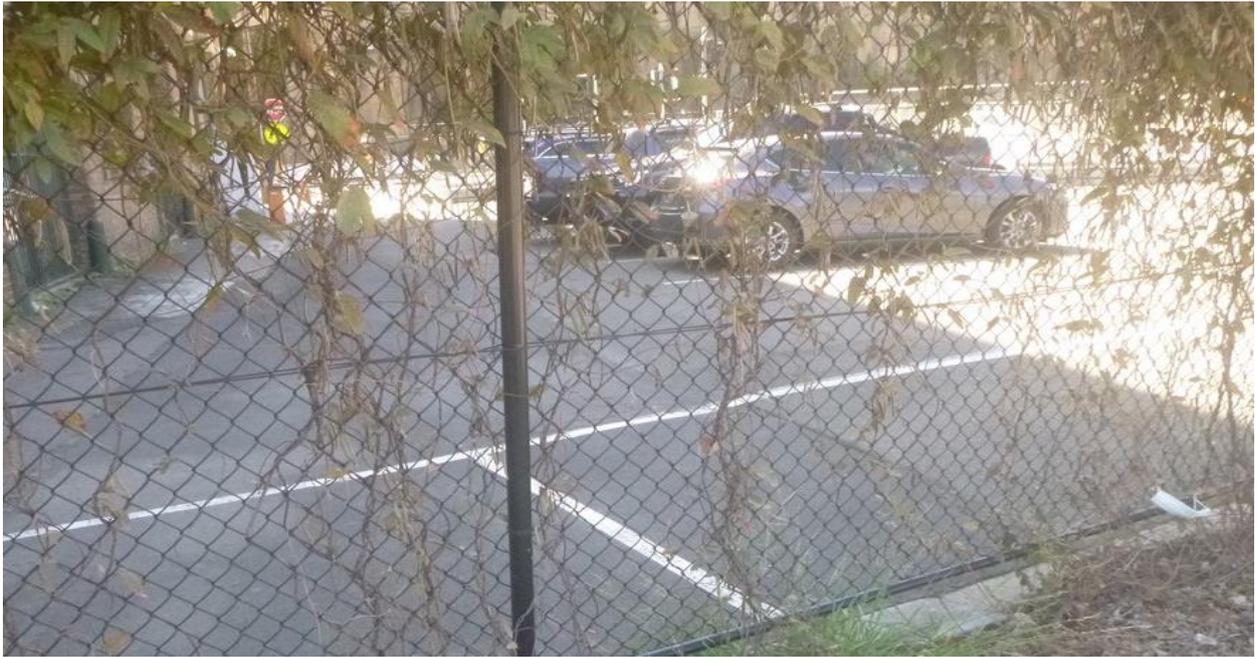
Photograph 3 - Parking area in front of building at 25 Hickson Road

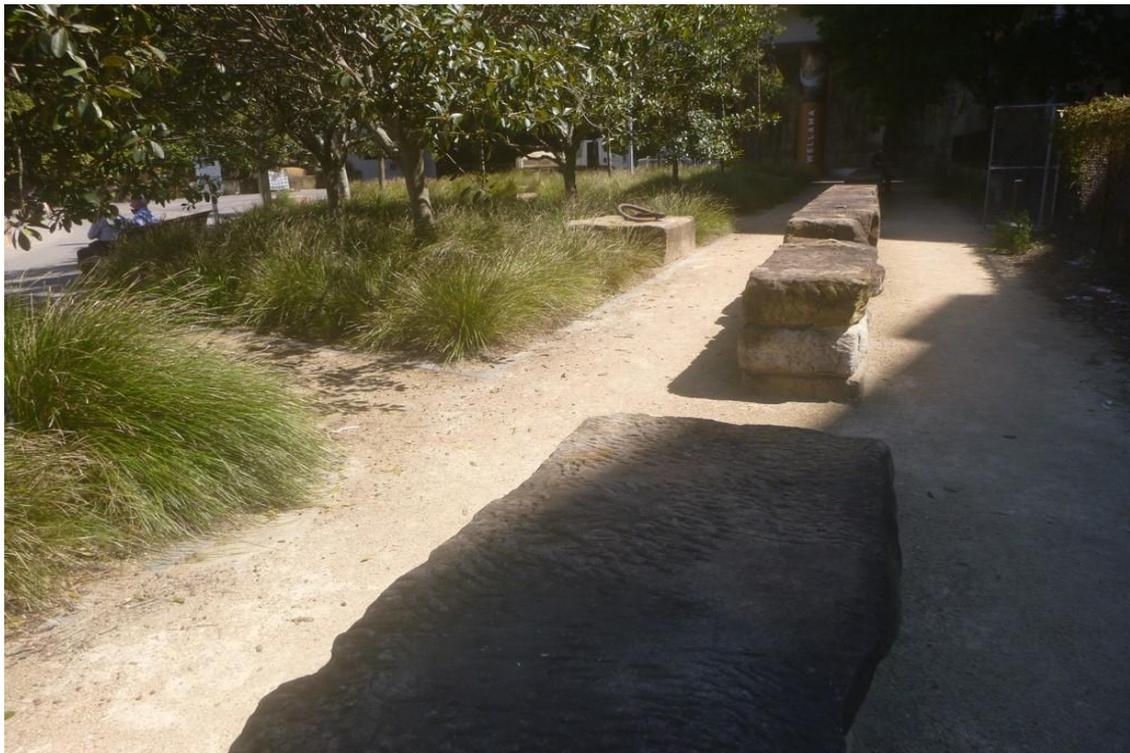
Photograph 4 - Landscaped area adjacent to the west of building at 25 Hickson Road

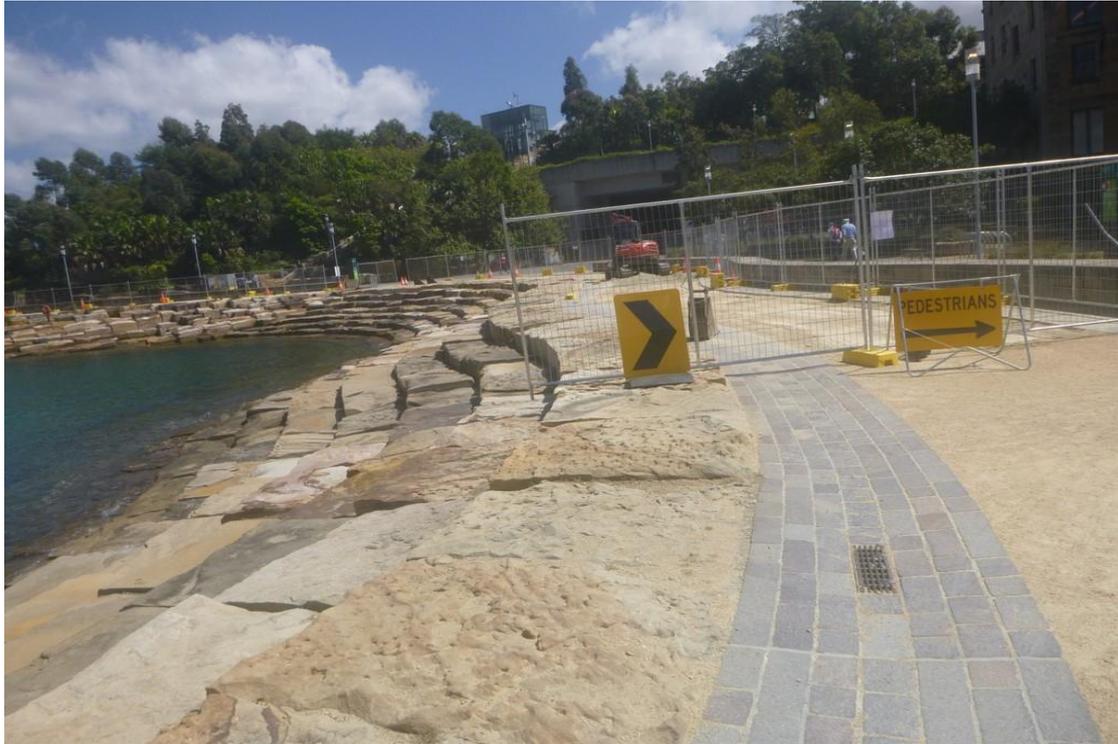
Photograph 5 - Eastern part of Nawi Cove

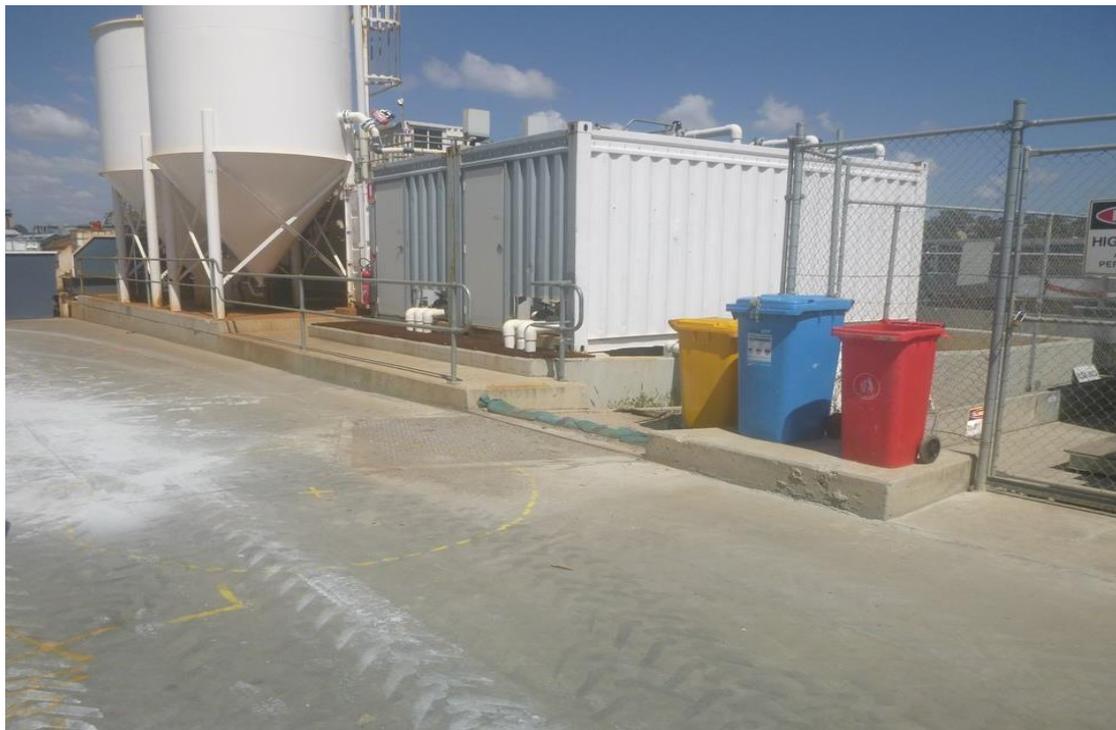
- The water treatment plant was situated (within the construction site) to the west of the station box extent. Sludge collection skip bins were observed at the water treatment plant;

Photograph 6 - Water treatment plant

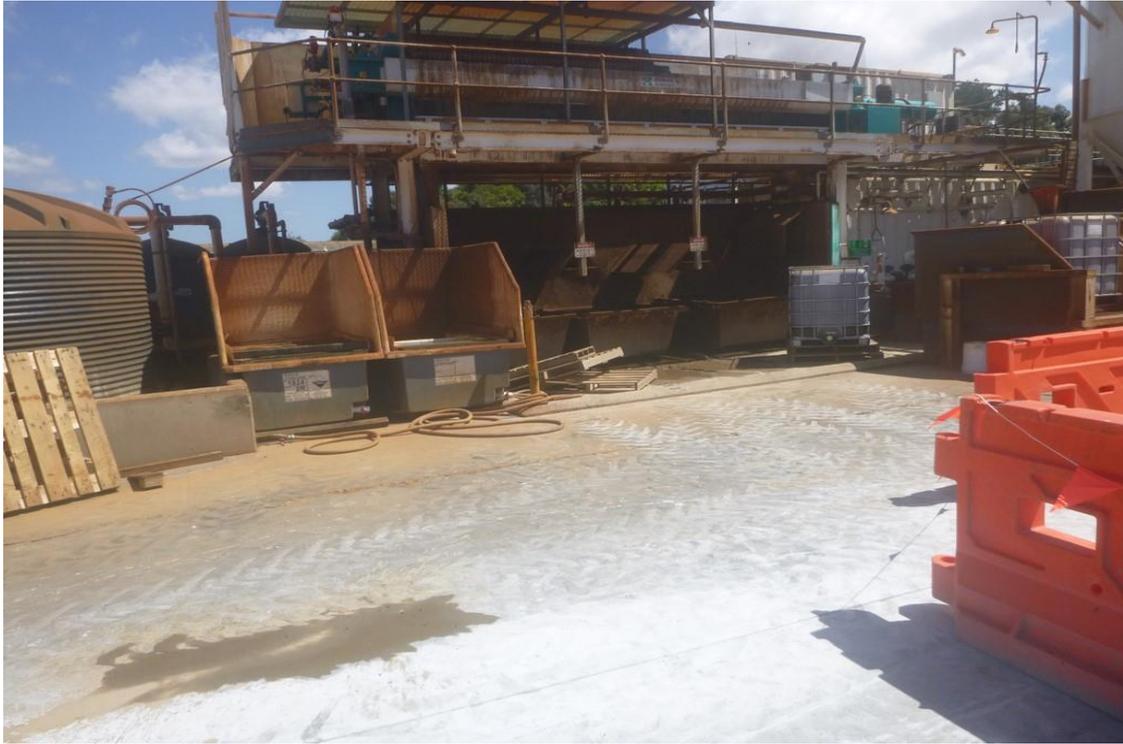
Photograph 7 - Water treatment plant

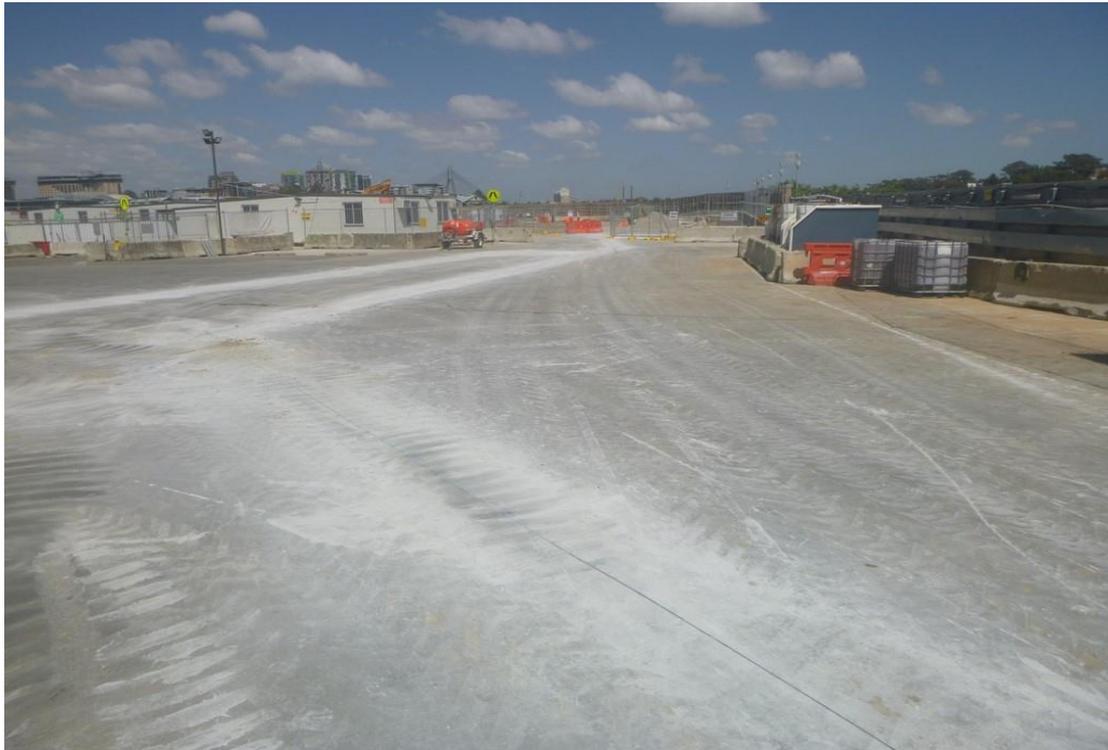
Photograph 8 - Western part of site

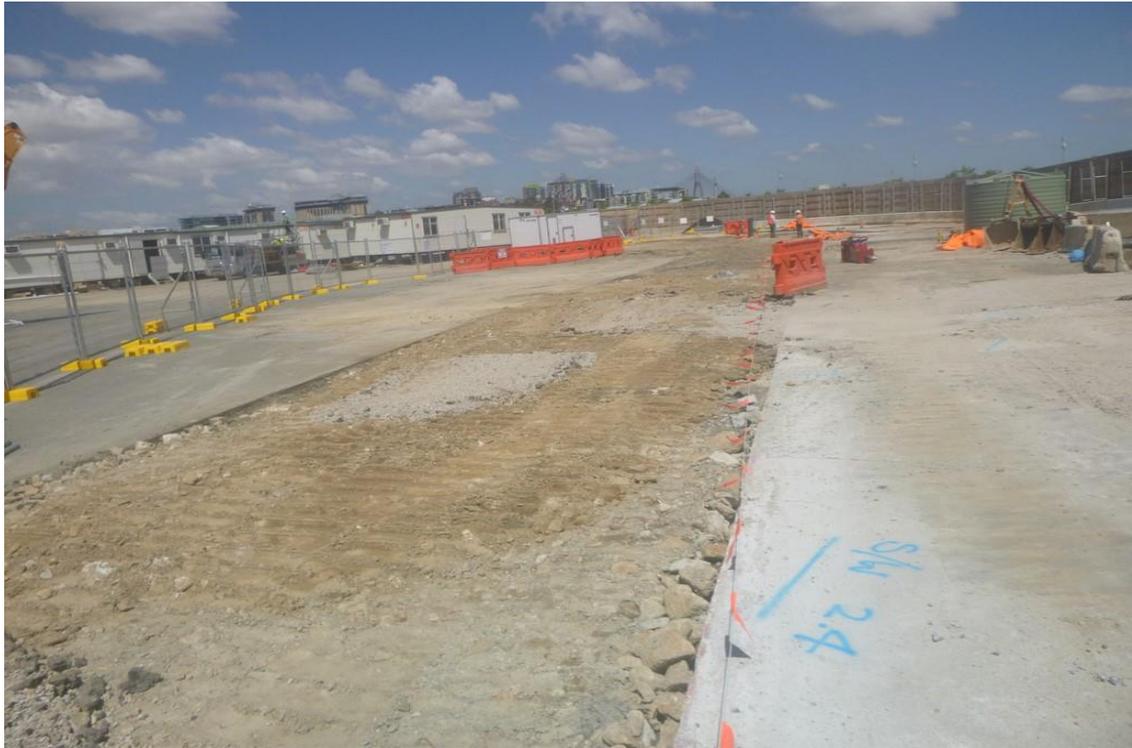
Photograph 9 - Western part of site where there has been recent test pits

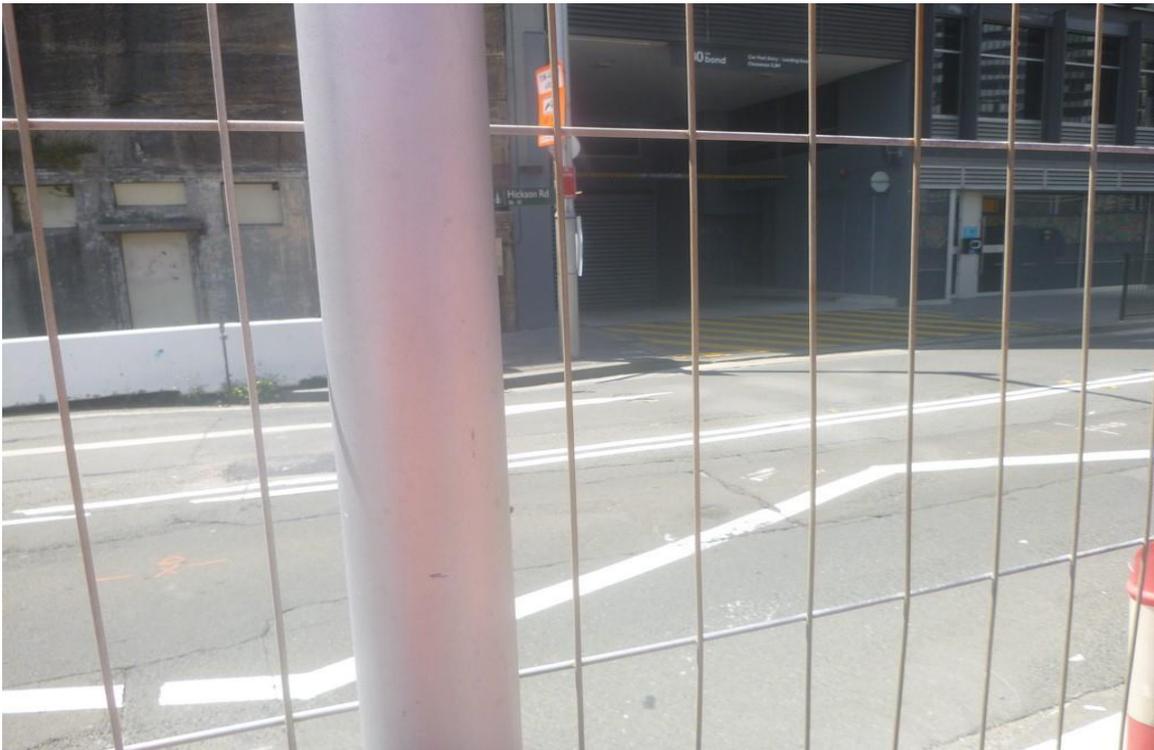
Photograph 10 - Southern end of site (Hickson Road)
