Aboriginal Cultural Heritage Management Plan

Sydney Football Stadium

Stage 3 More Park Precinct Village and
Car Park

Prepared for Besix Watpac
June 2024

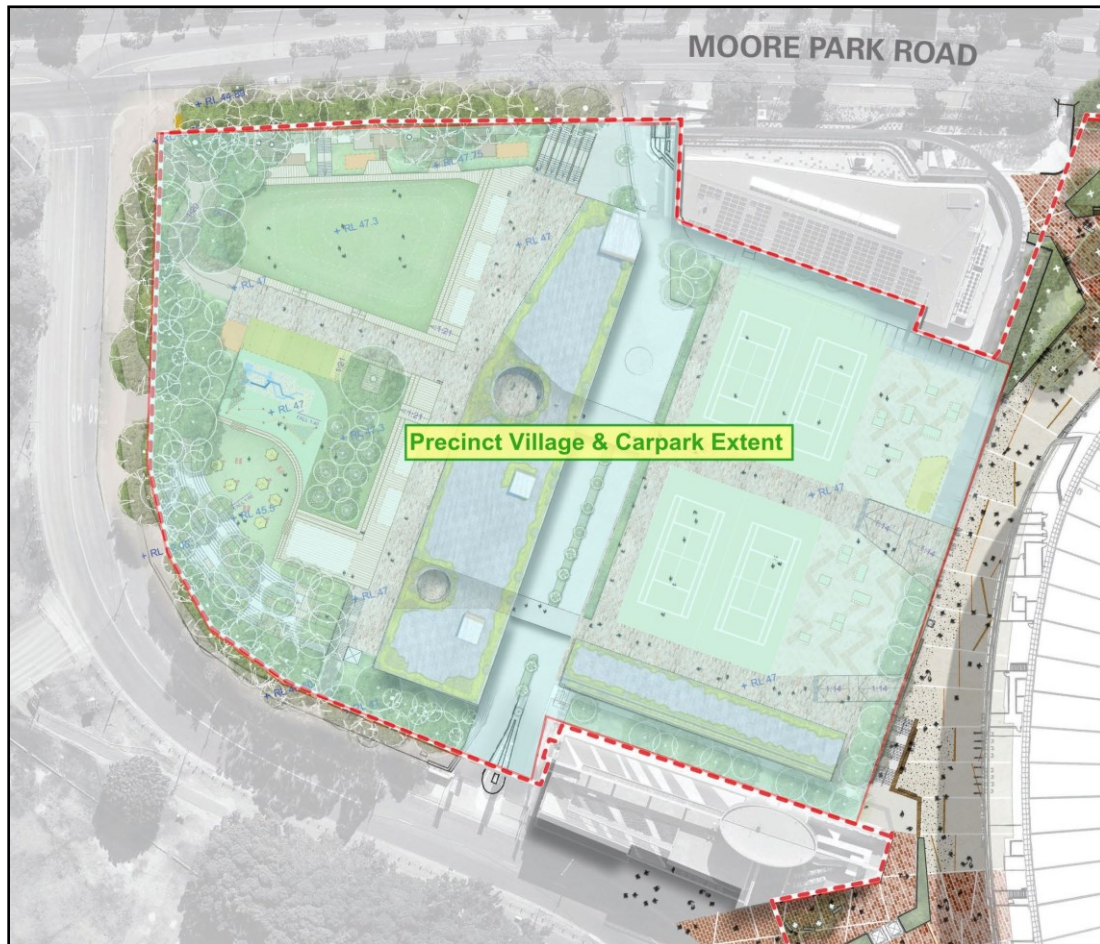
Figure 1: Proposed design of the SFS PV&C (Source John Holland)

The PV&C development will deliver a new 1500-space underground multi-level car park and Precinct Village above, linking the SFS at the Public Concourse level. The new development will substitute the former SSDA approved 540-space at-grade carpark, formally operated on this parcel of land prior to the demolition of Allianz Stadium.

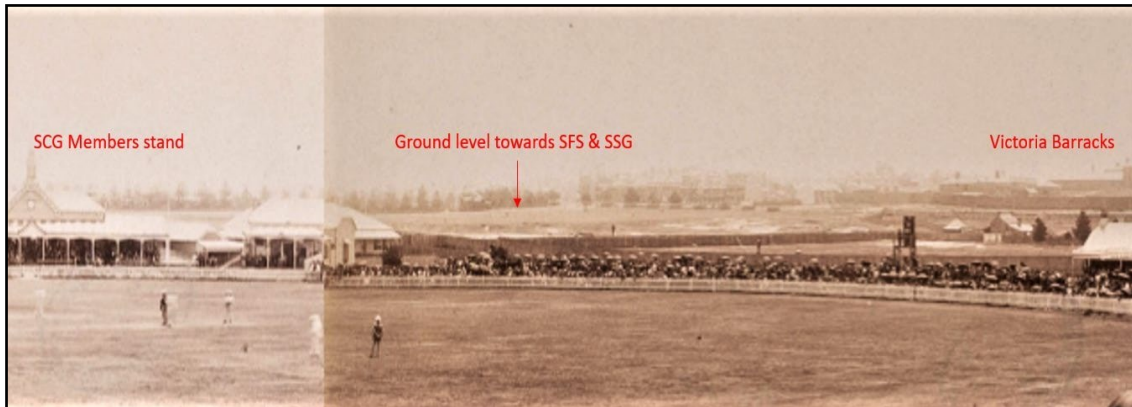
Figure 6: Cricket match at the SCG 27/1/2019. View north west (Trove NLA)

In 1875 works commenced to form the Sydney Cricket Ground.¹¹ A photograph of a cricket test match played at the S Cricket Ground in 1883 shows the future location of the SFS in the background as a raised piece of land, rising upwards to the north west (Figure 7). Two historical photographs from the same day (27 January 1883) have been spliced to create Figure 6 below. The Sydney Cricket Ground Members stand, and the Victoria Barracks remain in situ today, allowing for a definite identification of the Sydney Football Stadium future location from this photograph. The row of conifer trees in the background of Figure 6 is almost certainly the row of trees shown eight years earlier in Figure 5 as juvenile plantings along Anzac Parade.

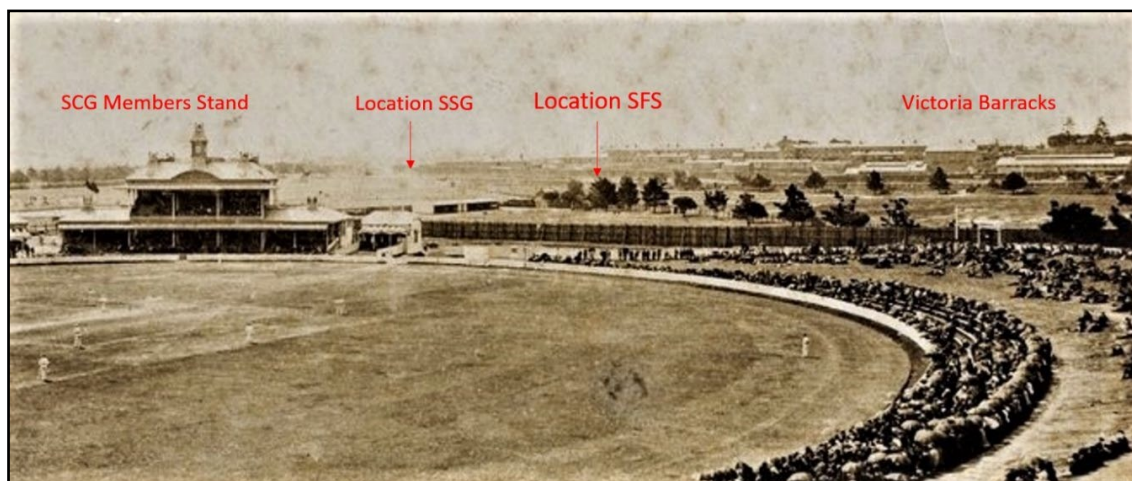
Figure 7: Cricket match at the SCG in 1892. View west north west (Trove NLA)

A photograph of another cricket match played nine years later in 1892 looks slightly more to the west (Figure 7) and is taken from a higher elevation. This image shows the raised ground of the future Sydney Football Stadium and Sydney Sports Ground (SSG), and also illustrates that the Sydney Cricket Ground was likely cut significantly into local dunes to produce banked or bowl like sides as seating.

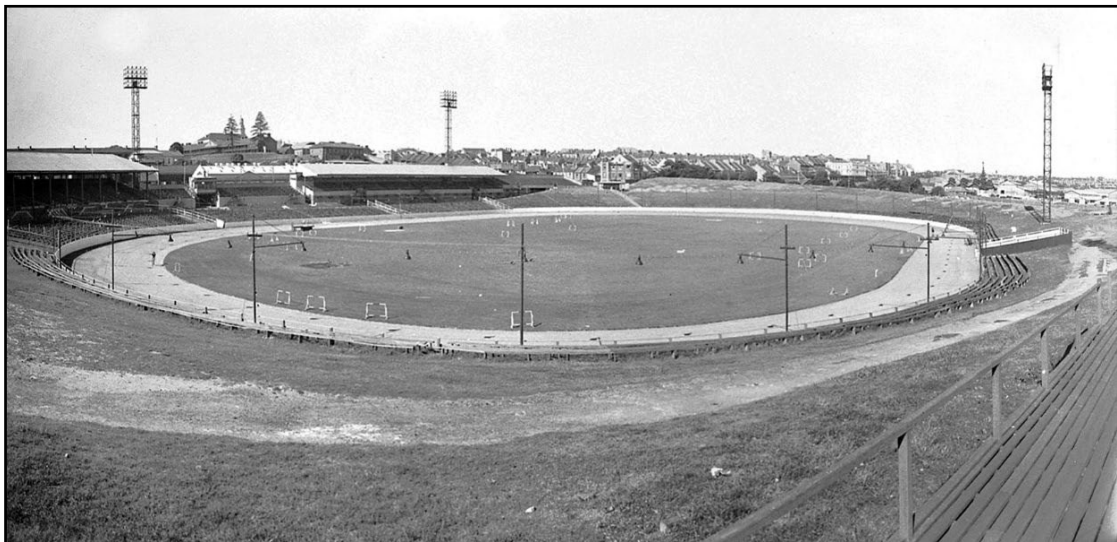
Figure 8: Sydney Sports Ground in 1937. View north east (Trove NLA)

This proven technique of excavating a flat playing surface into surrounding dunes appears almost certain to have been followed in construction of the SSG located to the north east of the Sydney Cricket Ground and partly within the footprint of the Sydney Football Stadium. Dedicated in 1899, the SSG was opened in 1903. It had been excavated to depth below the surrounding landscape and
