Barangaroo Station COP Archaeological Excavation Report

Prepared by AMBS Ecology & Heritage
for BesixWatpac

June 2024

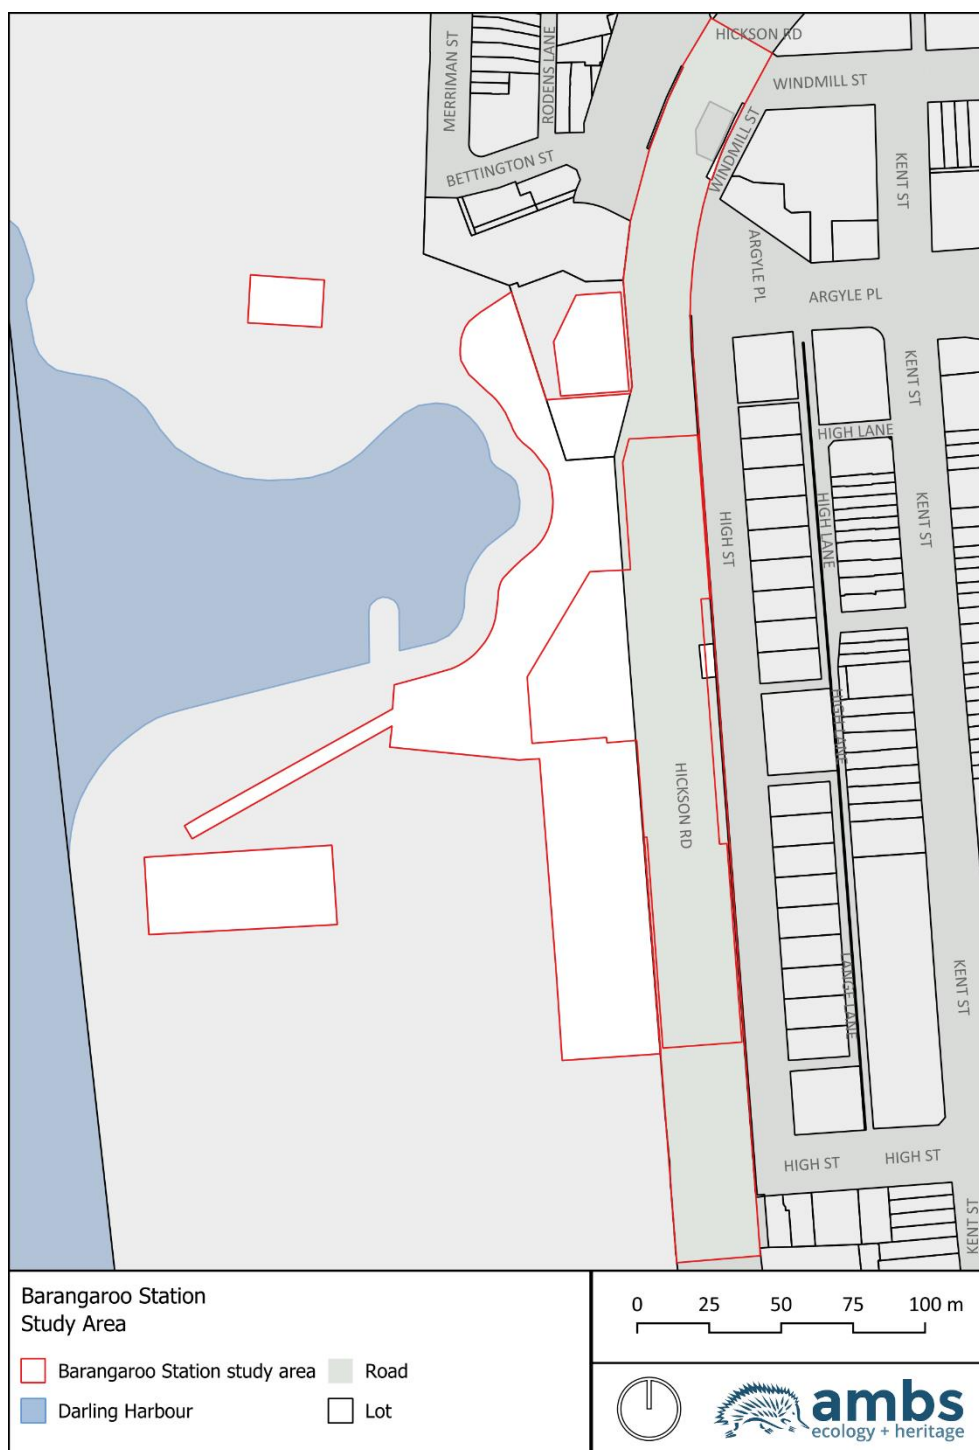
Figure 1.1: The study area excludes the station box which has already been archaeologically excavated.

The study area is located at Hickson Road, Barangaroo, and Hickson Road, Millers Point, in the City of Sydney Local Government Area and includes Lot 100, DP 838323 and Lot 52, DP1213772. It comprises parts of Hickson Road and the Baranagroo foreshore including Nawi Cove (Figure 1.1). It is located within the Parish of St Philip and the County of Cumberland.

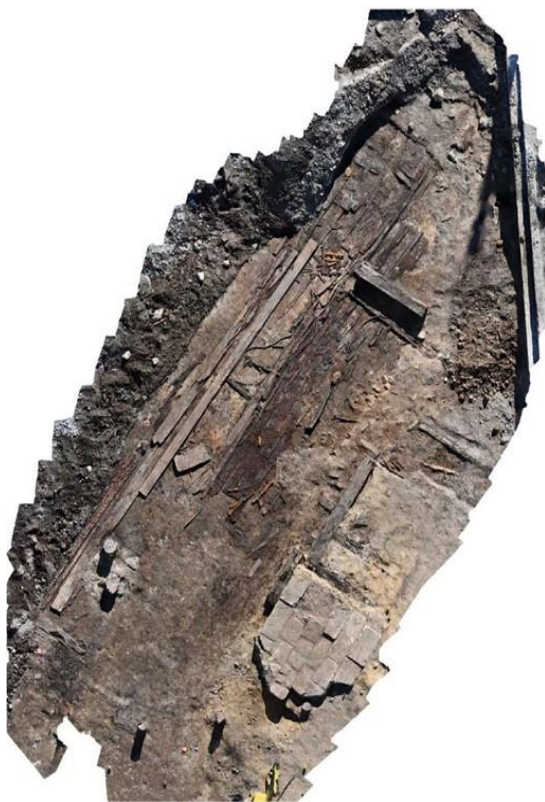
Figure 3.2: Orthophoto of Area T showing timber debris on Cuthbert's Wharf (Casey & Lowe, 2019, p. 18)

In Areas R and T (immediately adjacent to Work areas 1 and 2 in the current project), the investigations found evidence of Cuthbert's shipbuilding yard and wharf (1854-1875) and Dibbs's seawalls and wharfage (c.1875-1899). The remains included timber debris, extensive evidence of woodworking and distinct areas of activity on Cuthbert's wharf surface. Cuthbert's seawalls and a slipway, and piles for suspended wharfage were also found in good condition. Modifications to the walls and slipway that were undertaken by Dibbs, and contemporary public steps and paving were found at the termination of Clyde Street. Cuthbert's wharf and shipbuilding yard, and buildings associated with Dibbs' use of the wharf are also partly located within Work Zones 1, 2 and 5 of the current project.

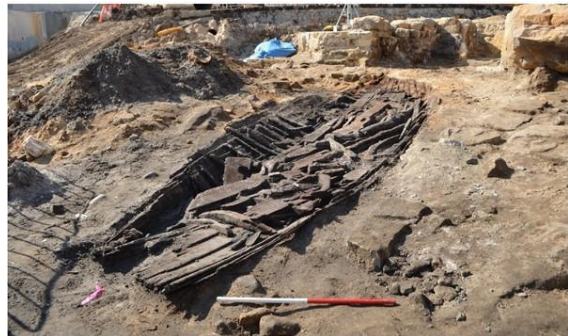
Figure 3.3: Remains of vessel UDHB1, Area X (Casey & Lowe, 2019, p. 36)

The remains of a rocky and sandy intertidal zone that predated the extension of Clyde Street was found beneath Hickson Road (in Area X), next to the foundations of an 1830s house. Partly buried by the beach sand was the remains of a 30ft boat that had been abandoned prior to the construction of Cuthbert's wharf. Similar intertidal environments are thought to have existed within the current study area adjacent to boatbuilding businesses in Work Zones 3 & 4 South.

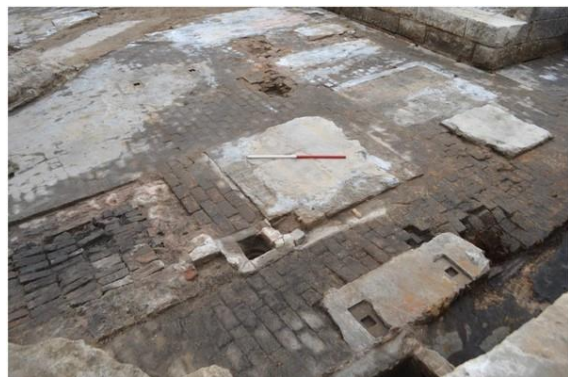
Figure 3.4: Foundations and floors of late nineteenth century wharf structures, Area Z (Casey & Lowe, 2019, p. 43)

In Areas Y and Z were the remains of late nineteenth century wharf structures, built on the outcropping sandstone and reclaimed land beneath Hickson Road. The truncated remains of a well or cistern associated with housing on Wentworth Street was located in Area Z adjacent to Work Zones 3 & 4 North, and Work Zone 6.

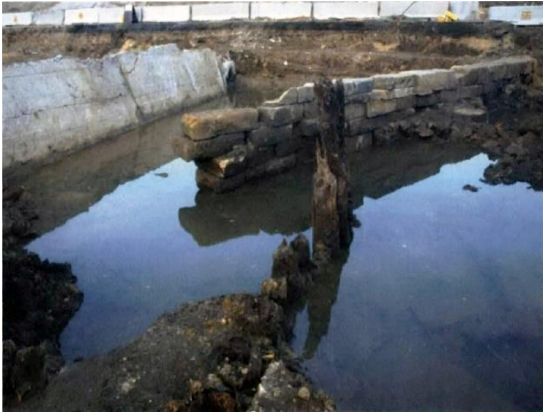
Figure 3.5: Dibbs' seawall to the northwest of the study area (Austral Archaeology, 2016, p. 99)

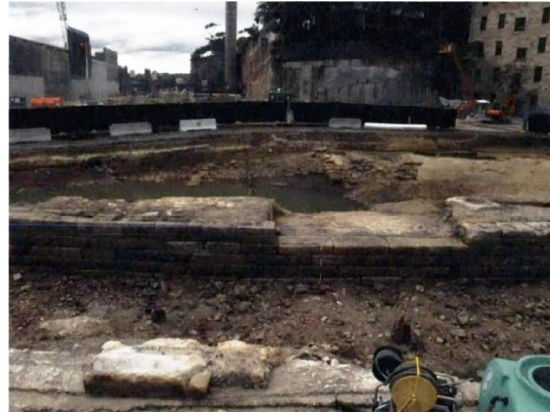
Figure 3.6: Dibbs' seawall looking northeast towards Dalgety stores (Austral Archaeology, 2016, p. 99)

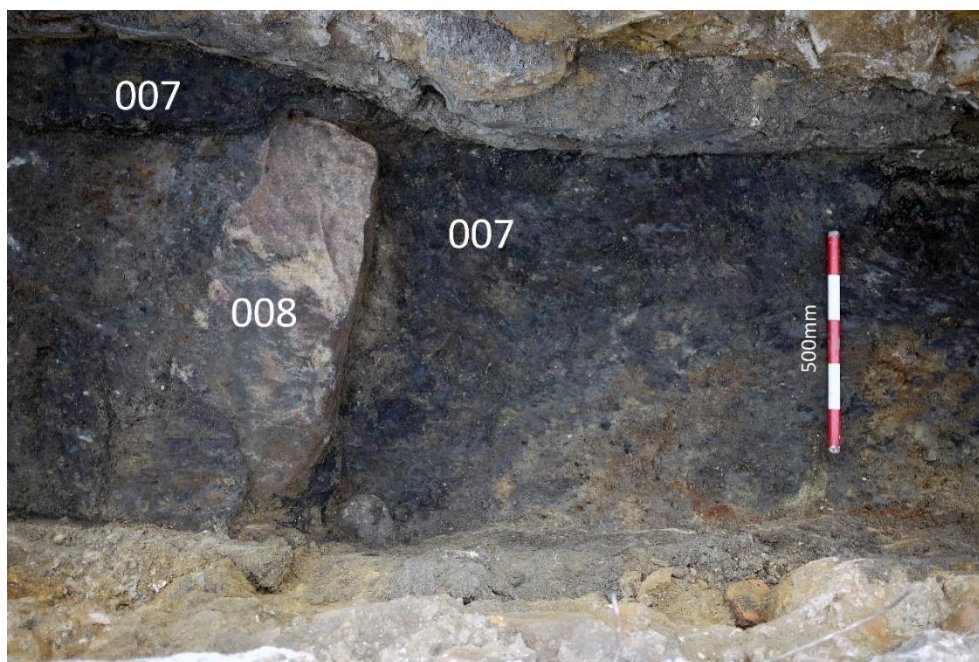
Figure 4.7: View to the east showing the top of sandstone structure 008 and surface 007 covering the extension (right of 008) and the original wharf (left of 008).

Context 009 was a fill of very compact, yellow brown clayey sand and sandstone rubble. It abutted the sandstone block on the northern side and had been built up against it after it had been laid. Surface 007 had built up on the top of the infill. The dark organic and mineral content of the surface had stained the top of the fill.

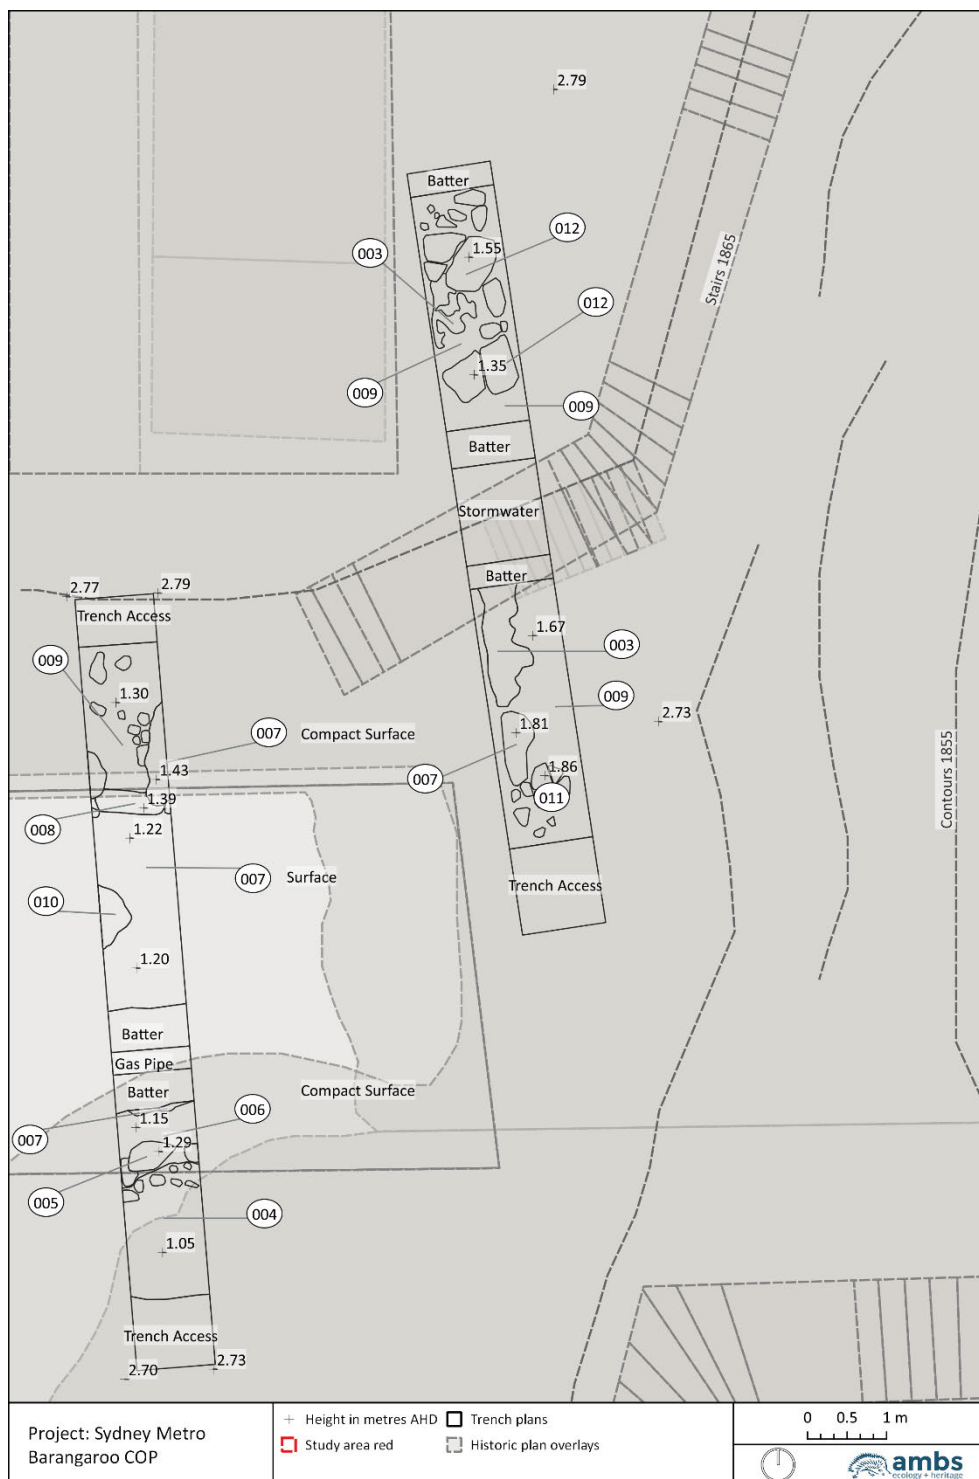
Figure 4.9: Trench 1 (left) and Trench 2.1 (right) overlain with traces of the 1834 and 1855 plans of the site showing how the features line up with the historical layout of the foreshore.

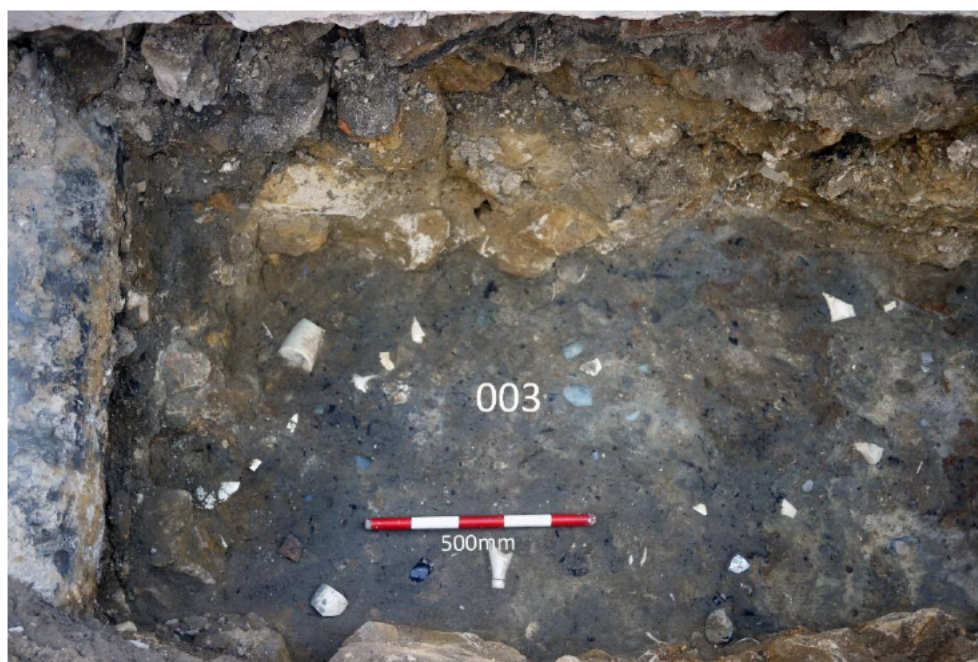
Figure 4.12: The top of context 003 beneath Hickson Road construction fills. View to the west.

Context 003 was a ground-raising fill that was spread in a very large quantity across the whole of the trench. It was on both sides of the property boundary, was up to 740mm thick and completely covered the earlier structures and surfaces. No surface had developed between context 004 and 003 suggesting that they were laid down within a short period of each other, or were contemporary. Context 003 contained a large number of glass and ceramic artefacts dating to the late nineteenth century. They included whole bottles and large fragments typical of bulk dumping events. It consisted of layers of sandy clay with visible tip lines in section and was grey-brown in colour (Figure 4.12).

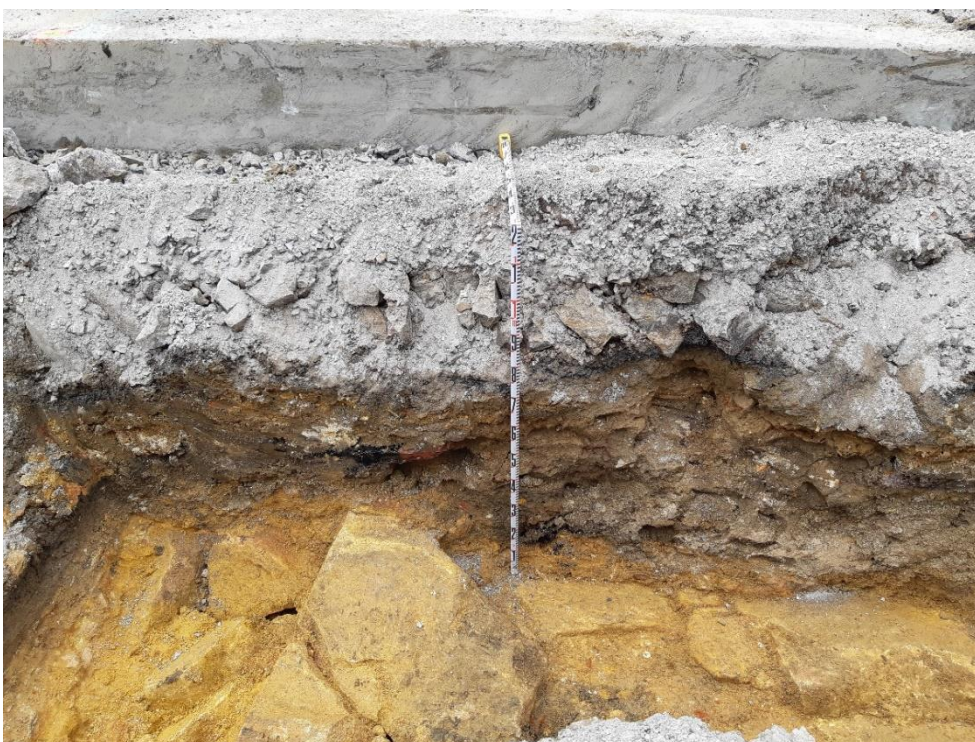
Figure 4.13: Sandstone rubble used as base reclamation fill (012) shown immediately beneath the clay construction fills for the road. All significant archaeology was removed from this area.

An early wharf-building fill (012) in the form of fractured sandstone and rubble was exposed in the north of the trench at RL 1.35m (Figure 4.13). This type of fill is typically utilised in the intertidal zone as a base fill for reclamation and wharf-building because of its robust and unerodable nature. Its presence here (at almost 1m above high water) may be more indicative of the ready availability of sandstone on the steep and rocky shoreline. The large rubble was packed with crushed sandstone and sandstone fragments, producing a compact and well-stabilised fill. Context 012 was capped with context 009, which was a fill of very compact, yellow brown clayey

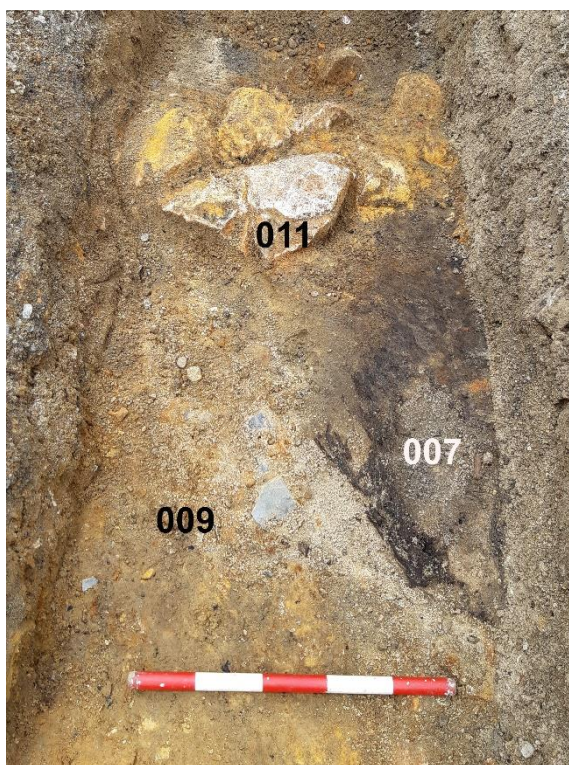
Figure 4.14: Feature 011, remnant surface 007 and bulk fill 009 in Trench 2.1. View to the south. Scale 500mm.

Surface 007 was only present in a small patch measuring 900mm x 250mm (Figure 4.14). In Trench 2.1 it was barely a skin of material on top of context 009, and had none of the signs of development and consolidation over time that were present in Trench 1. The top of context 007 was at RL 1.81m, around 400mm higher than the same context in Trench 1. It was only located in the south of the trench. In association with context 007 was a cluster of sandstone rubble (context 011) that appeared to be contemporary with the remnant wharf surface rather than the infill below. This arrangement of stone was in line with wall 008 in T1, and may represent the demolished remains of that structure. It was around 500mm higher (RL 1.87m) than the remains of 008 in Trench 1. The largest stone 320mm x 235mm and the smallest 100mm x 80mm. The overall measurements of the arrangement were 795mm x 740mm. On the whole, the remains of this feature were too limited to be able to identify meaningfully because of the small area and damage that had occurred by subsequent events at this level.

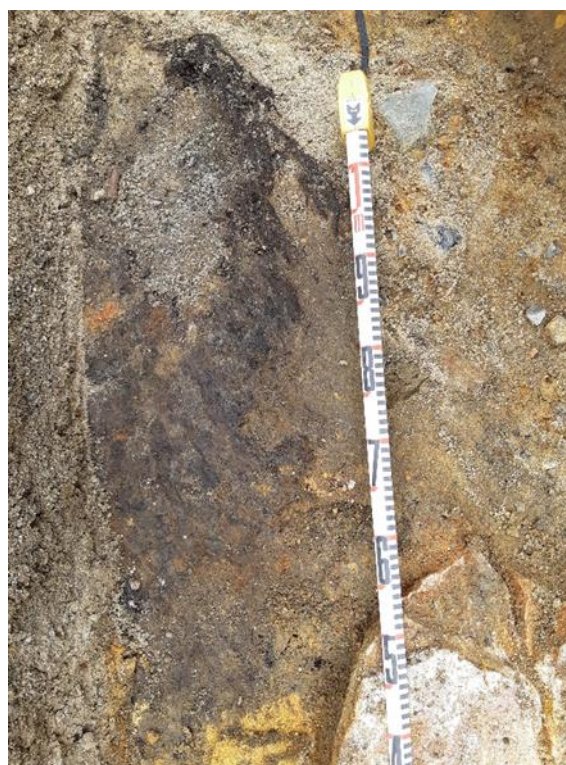
Figure 4.15: Detail of remnant surface 007. Numbers on the scale are in 100mm increments.

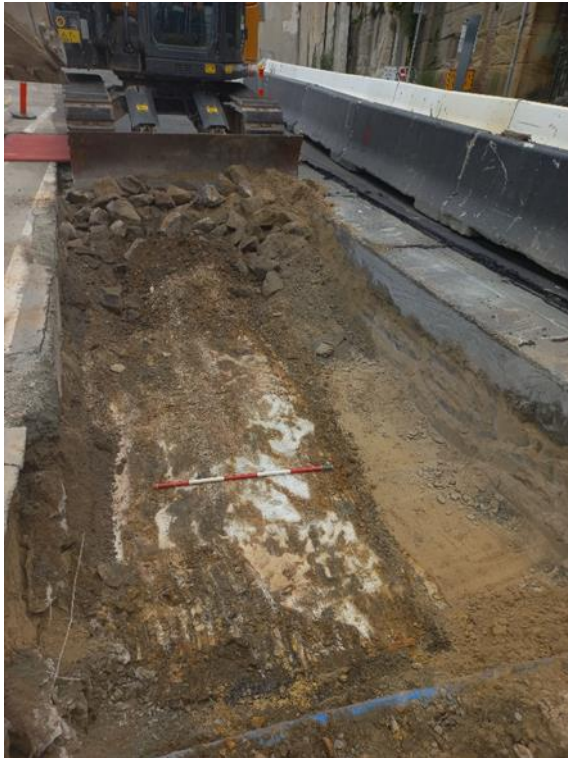
Figure 4.17: Cut-down sandstone bedrock as found immediately beneath the road construction fills in Trench 2.2. View to the north. Scale 1m.

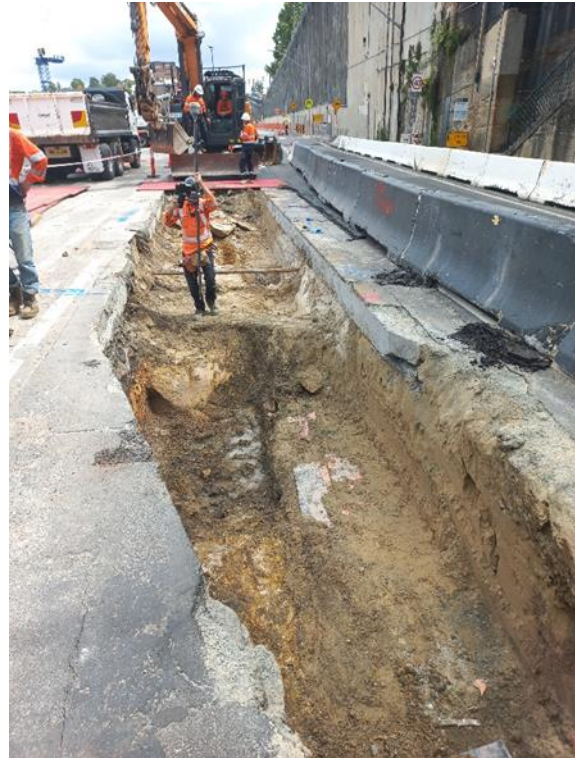
Figure 4.18: Looking north along Trench 2.2 showing the deep service trench on the right and the small dark brown patch of clay fill (016) in the foreground.

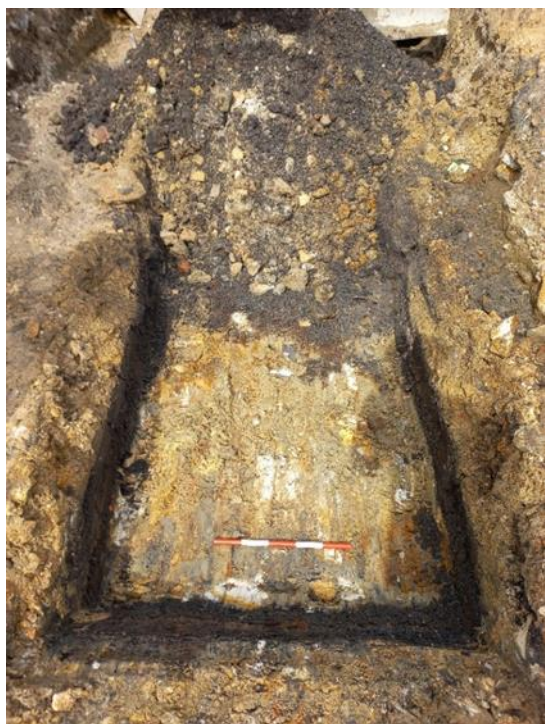
Figure 4.22: The earliest fill consisted of sandstone rubble. Scale 500mm. View to the southwest.

The earliest fill (112) consisted largely of sandstone rubble and was typical of the robust, permeable fills used to establish reclamation and wharf infill. The top of the rubble was at RL 0.332m (which would have been within the intertidal zone at the time of reclamation). It was capped with a fill of loosely consolidated, coarse industrial waste that was equally resistant to erosion and suitable as a reclamation fill at depths below high water. The top of the industrial waste fill (111) was at RL 0.667, bringing the infill above the waterline where more erodible fills could be used. Up to 250mm of yellow-brown clays (110) capped the industrial waste. None of these fills contained artefacts.

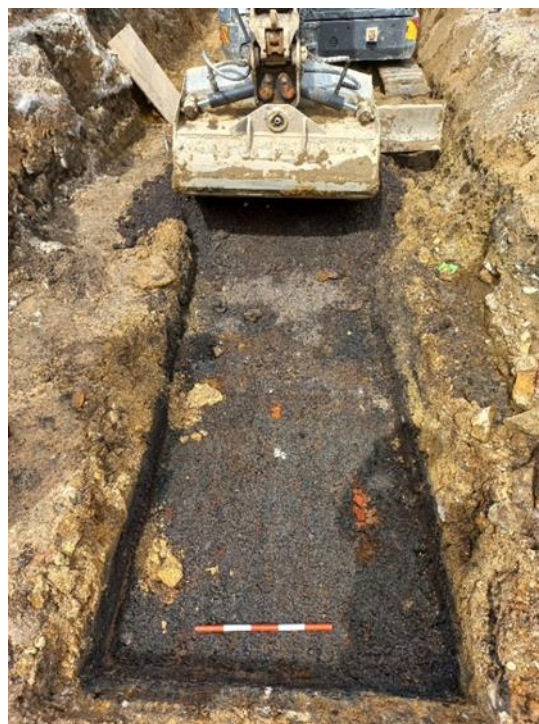
Figure 4.23: The sandstone rubble was capped with a fill of loose, coarse industrial waste. Scale 500mm. view to the southwest.

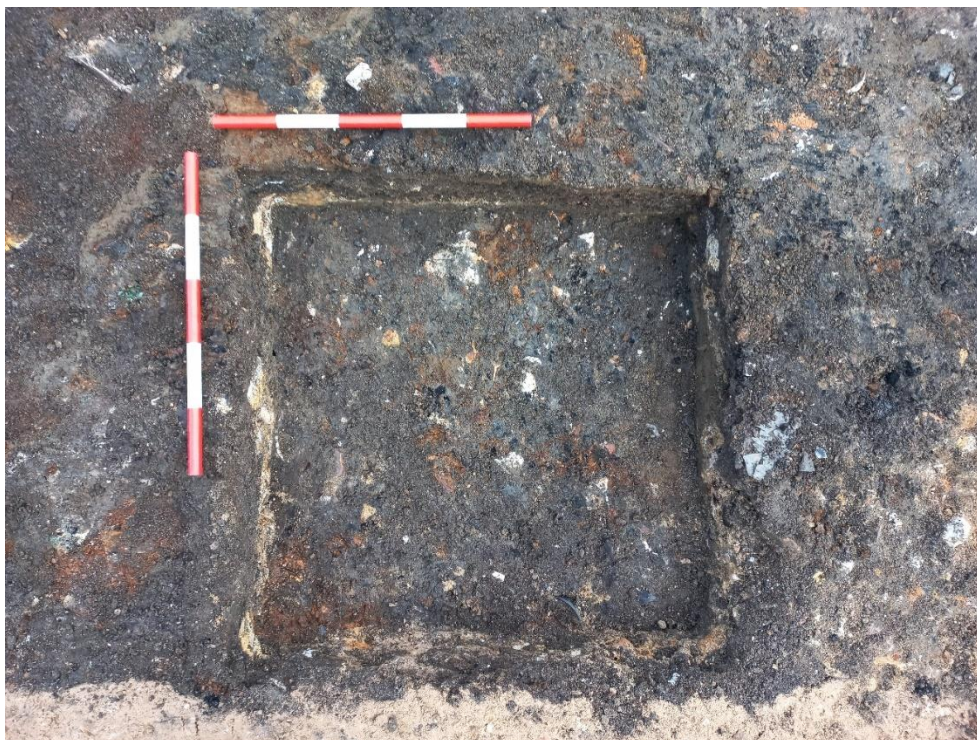
Figure 4.25: The lower (109) and upper (107) wharf surfaces separated by 200mm of fill. This image shows their similarities in composition, inclusions, and artefacts. Scale 500mm.

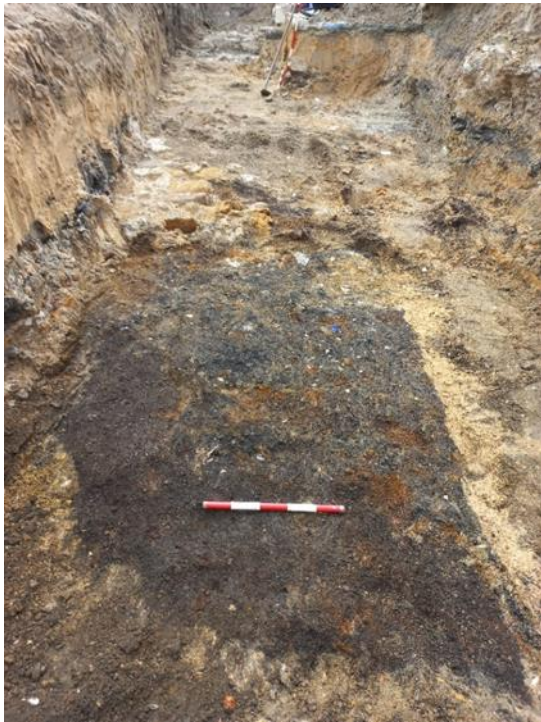
Figure 4.26: The surviving patch of upper wharf surface in the stormwater trench. View to the northeast. Scale 500mm.

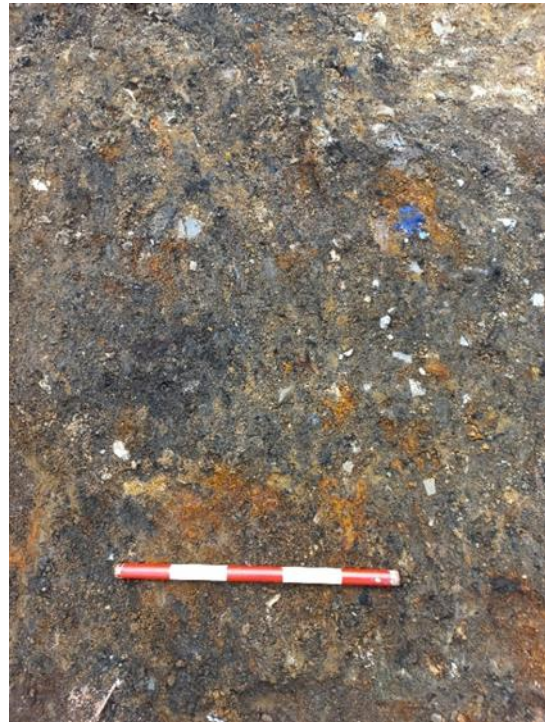
Figure 4.27: Detail showing artefacts embedded in the upper wharf surface in the stormwater trench. Scale 500mm.

Perhaps as early as 1865, the wharf surface was raised by around 200mm. Industrial waste, clay and fragmented sandstone (context 108) were used to raise the surface, where a compact mix of silt, industrial waste and sand had formed a crust at RL 1.21m. The surface was frequently embedded with fragments of ceramic, glass and bone of a domestic nature, suggesting that the same processes and events were in play across the development of the two surfaces. Within the 4m x 2m patch of upper wharf surface that remained, there were 43 animal bones, 15 shells, and 91 other artefacts including 36 ceramic and 25 glass items. All of the shells were from two commonly eaten species: Sydney Rock Oyster and Sydney Cockle, and all were of a size suitable for eating.

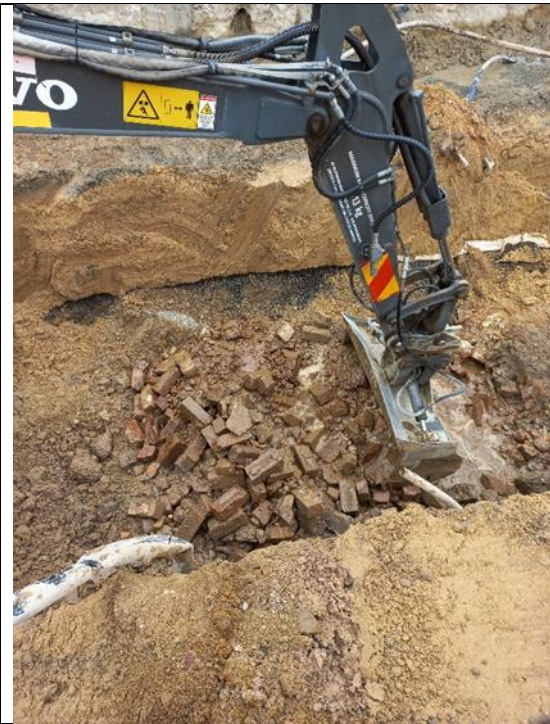
Figure 4.31: Sand and modern construction material dominated the bulk fills in the stormwater trench. The clean sand and gravel fill of deep services can be seen on the far (eastern) side of the trench. View to the east at the southern end of the stormwater excavation

The remainder of the stormwater trench to the south contained variations of context 105, occasionally containing large sandstone blocks, quantities of machine-made brick and concrete. All nineteenth century evidence had been removed from this part of the trench.

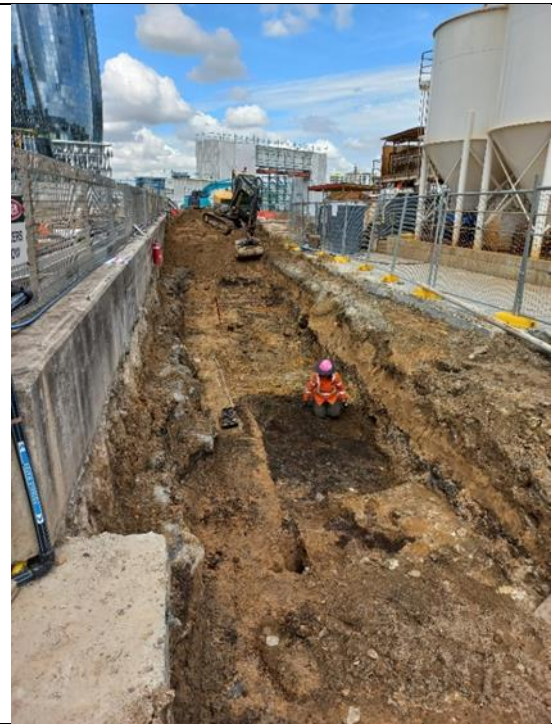
Figure 4.32: Only a small patch of archaeology (seen here as dark soil) was preserved in the stormwater trench. View to the southwest

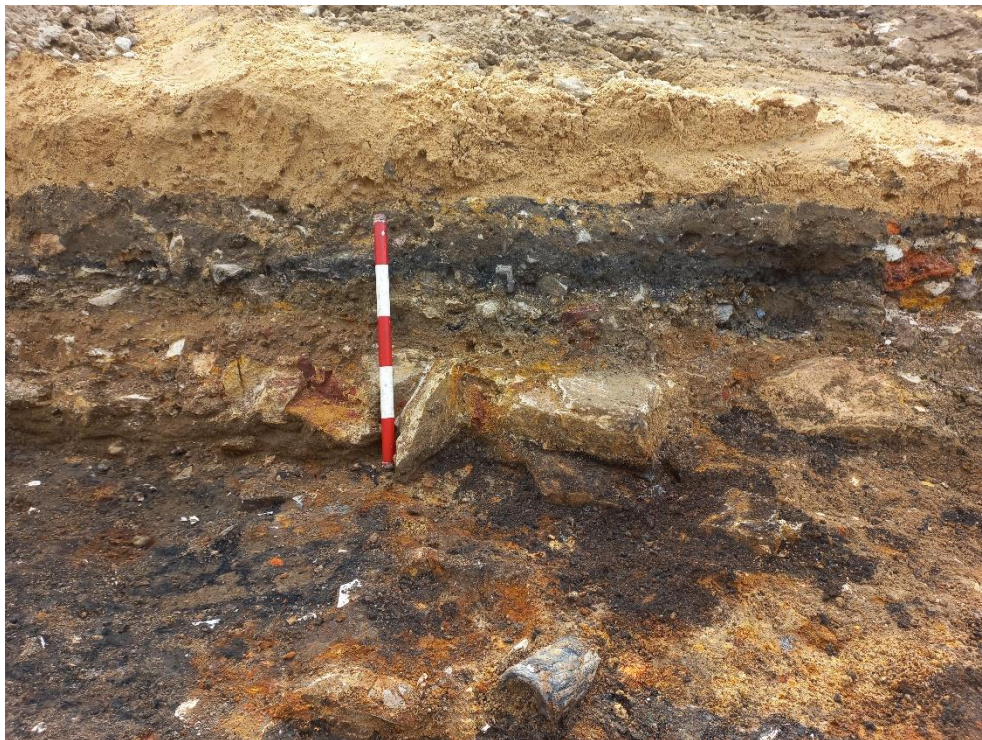
Figure 4.33: levelling fills shown above the wharf surface 107 in the east-facing section of Trench 4. Scale 500mm.

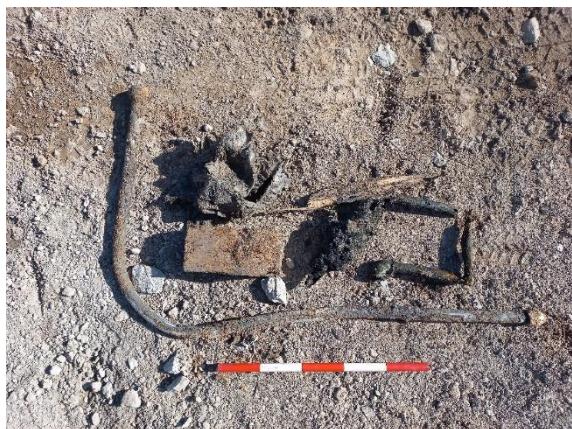
Figure 4.36: Objects from within the fill below 2.8m in Test pit 1. Scale 500mm.

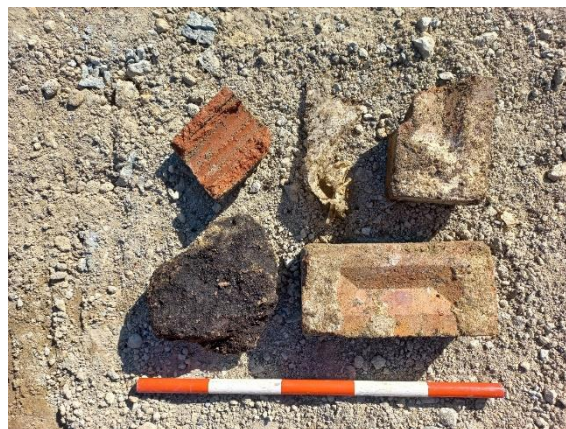
Figure 4.37: Objects found in the fill below 2.5m in Test pit 2 including plastic sheeting (centre top). The object at lower left is probably a fragment of what was once a compacted surface of industrial waste and silty sand.

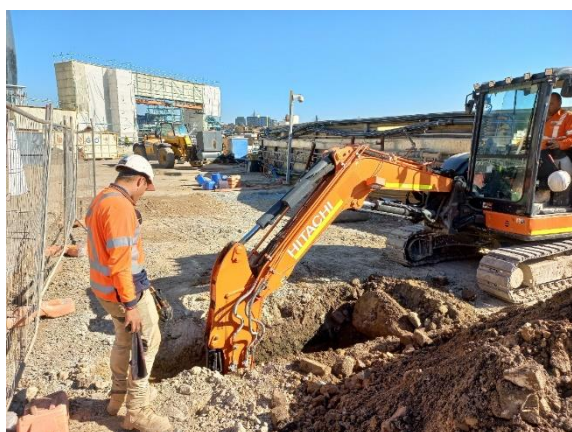
Figure 4.38: Excavation of Test pit 3 looking south.

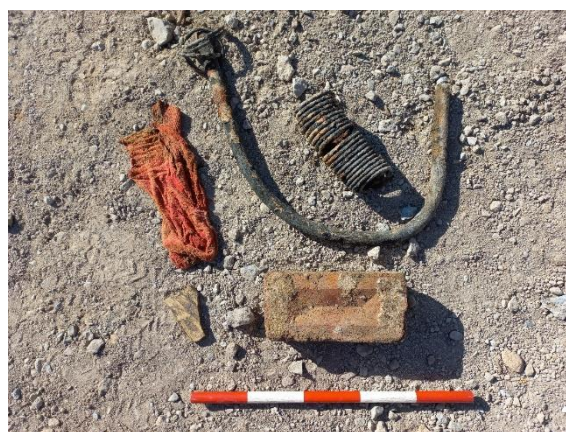
Figure 4.39: Objects found between 2.5m and 3m in Test pit 3. Scale 500mm.

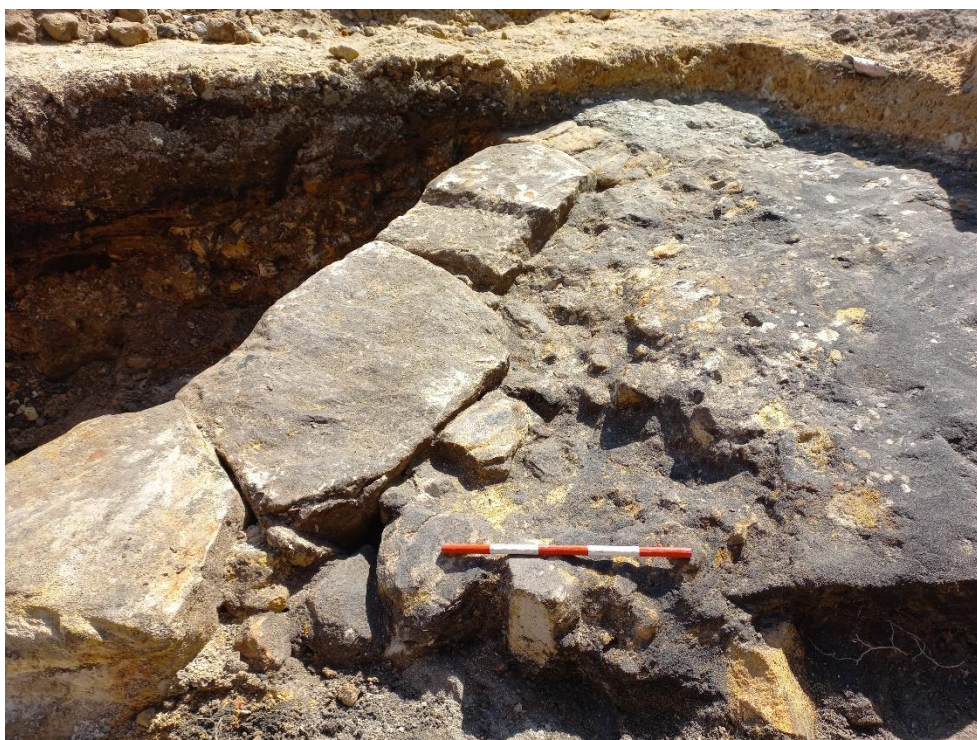
Figure 4.43: The compact black sandy surface 207 behind wall 208. View to the west. Scale 500mm.

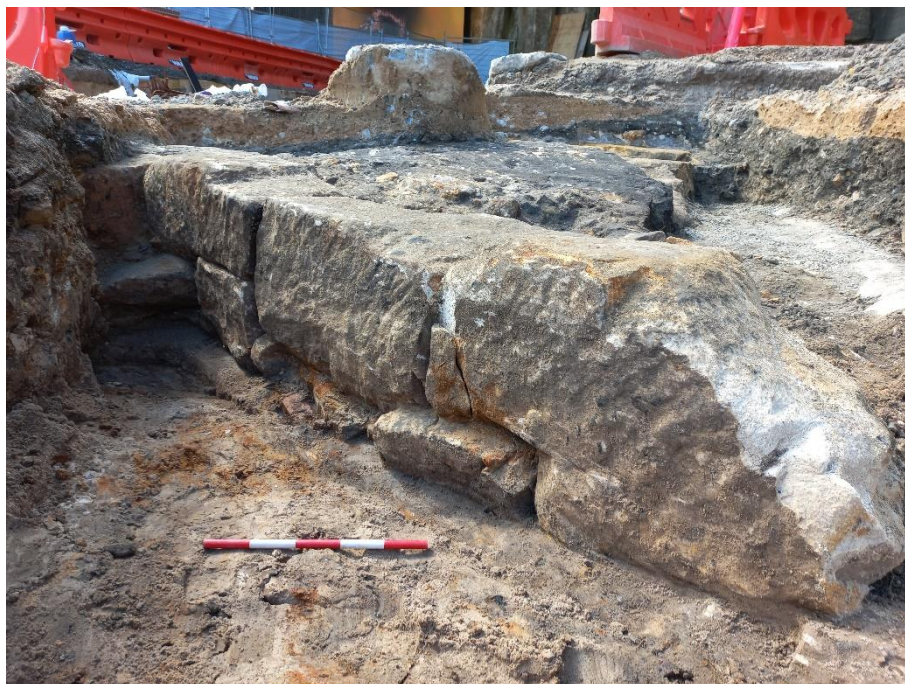
Figure 4.44: The seaward side of wall 208 on the western side of the trench showing the sandy deposit 210 in the foreground. View to the north. Scale 500mm.

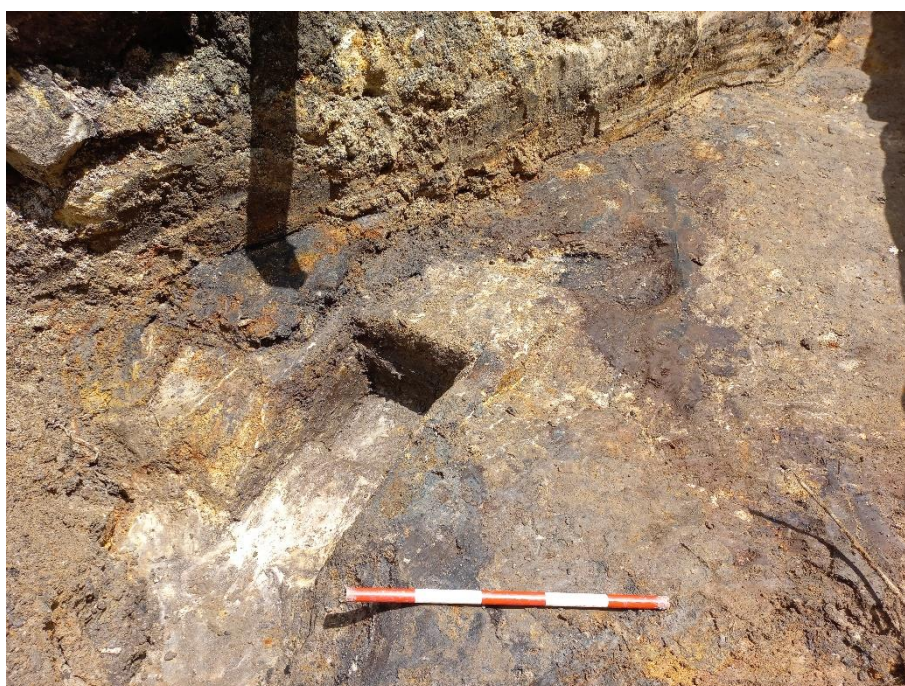
The bedrock had been cut down on the seaward (southern) side of the wall by around 180mm-200mm, and a flat platform was created where the wall turned at a right angle. This would have been a labour-intensive modification that effectively raised the height of the wall without altering the established surface level. The bedrock at the base was at roughly RL 1.0m after it was cut down, and the total height of the wall was around 900mm. The reason that the bedrock was modified is not clear. A rectangular recess had been cut into the rock at a distance of 1.2m (4ft) from the east-west wall and 2.5m (around 8ft) from the north-south wall. The cut was 270mm x 240mm. it was 230mm deep and could have accommodated a substantial square-cut post around 10 inches wide.

Figure 4.45: Rectangular recess cut into the bedrock 1.2m south of the wall. Scale 500mm. View to the northwest.

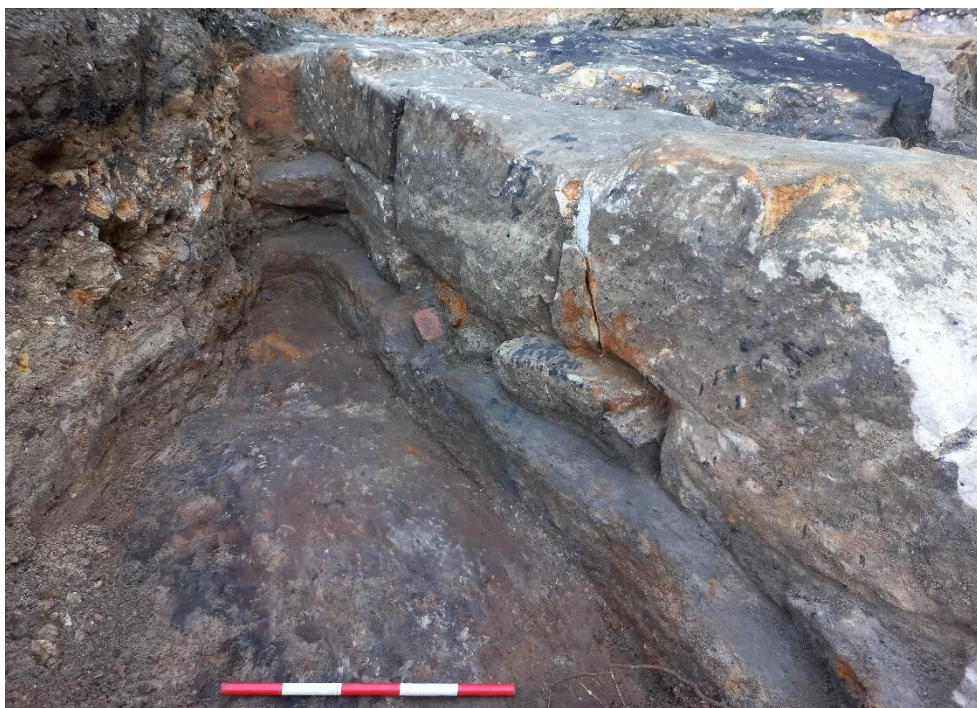
Figure 4.46: The cut down bedrock can be seen here below the wall. A thin brown organic skin has developed on the sandstone below. Scale 500mm. View to the north.

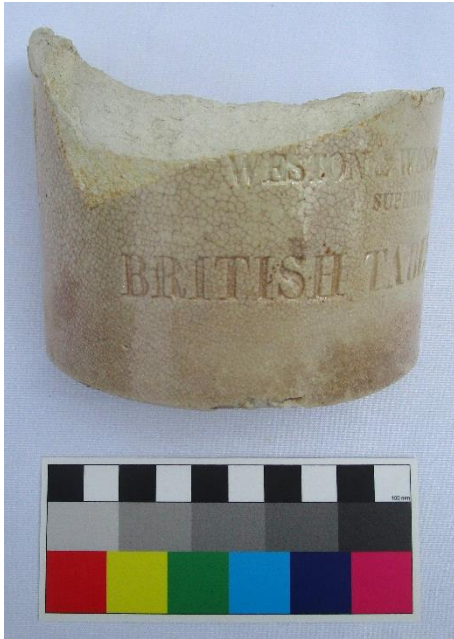
The first bulk fill (context 214) above the sand accumulations was the only artefact-bearing context in Trench 5.1. Context 214 was a bulk fill of pale brown-grey sand and sandstone fragments. A total of 33 individual items or 38 fragments were recovered from fill 214. There were 18 ceramics, 14 glass items and one brick fragment. It did not contain any bone or shell. Based on the manufacture date for a Weston & Westall fine earthenware salt jar and a light green cup bottom mould glass bottle, fill 214 was probably deposited sometime in the late 1840s or early 1850s. An 1850s date would correlate with the time at which we think Cuthbert's wharf was constructed.

Figure 4.47: Weston & Westall's salt jar (#231/214). Scale 10cm. Photo: S. Kuiters.

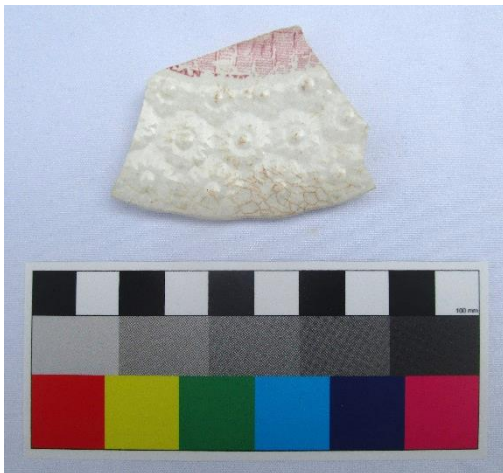
The majority of artefacts were associated with food or drink. These included a fragment of a child's plate and part of a glass tumbler. Other items include a blacking bottle, and a penny ink bottle. All of these items are commonly encountered on nineteenth century sites in Sydney, but are more typical of domestic deposits rather than industrial or worksite deposits. Given that the bulk fills used for reclamation or infill across the site were largely devoid of artefacts, it is possible that some of the objects were opportunistically disposed of by nearby residents during the infilling event.

Figure 4.48: Child's plate (#227/214). Scale 10cm. S. Kuiters.

Twenty-four out of the twenty-eight items for which a general function can be identified are associated with food or beverages (Table 0.10). These include a fragment of a red transfer print fine earthenware child's plate (#227; Figure 4.48), and part of a press moulded glass tumbler (#094). Other items include a blacking bottle (#232), and penny ink bottle (#234), both made from salt glaze stoneware. All of these items are commonly encountered on 19th century sites in Sydney, but are more typical of domestic deposits rather than industrial or worksite deposits.

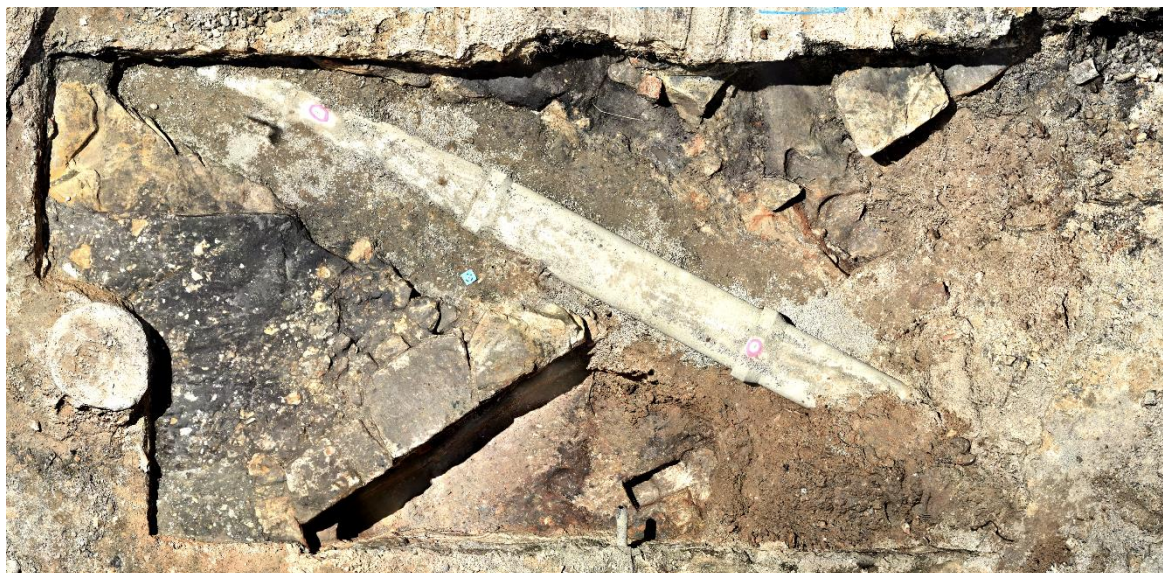
Figure 4.49: Orthophoto of the northern end of Trench 5.1 during excavation showing the wall (208) and surface (207) cut by the stormwater service. North is at the left of the image. (Guy Hazell/ArcSurv)

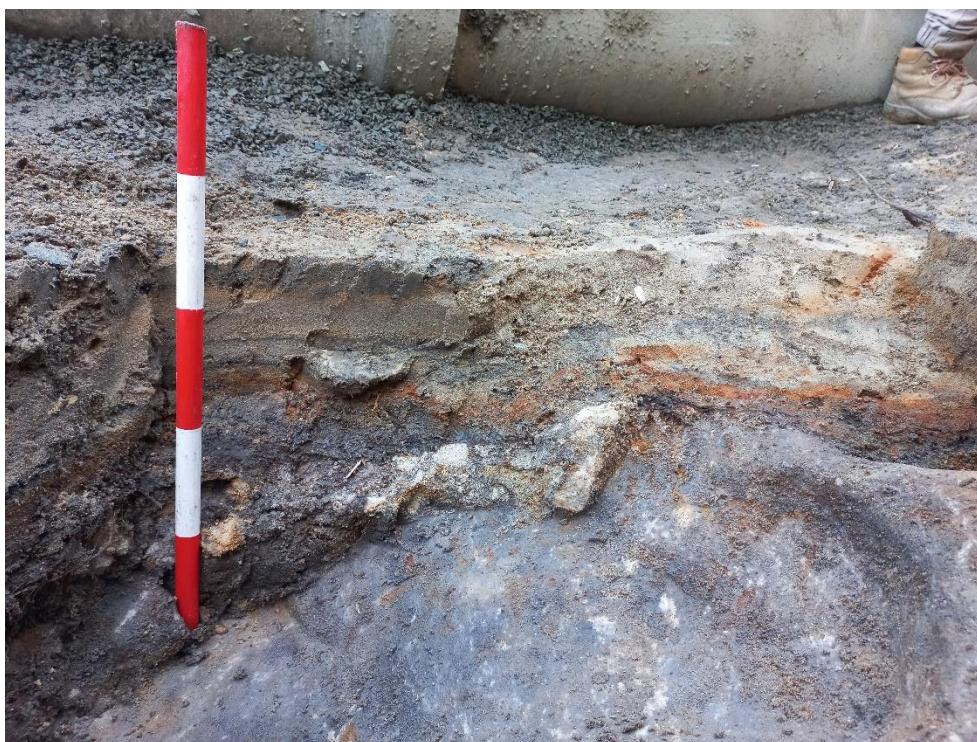
Figure 4.50: Lenses of silt and sand (210) built up on the bedrock in the east of the trench. Scale 500mm.

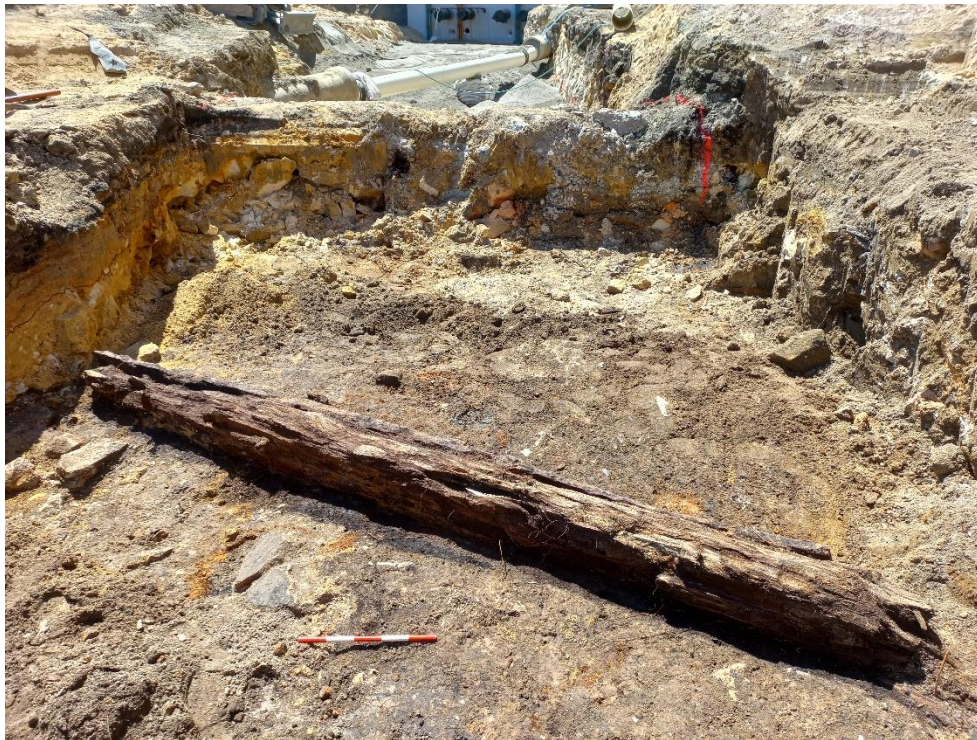
Figure 4.51: Isolated timber 218 on the sandstone rubble fill in Trench 5.2.

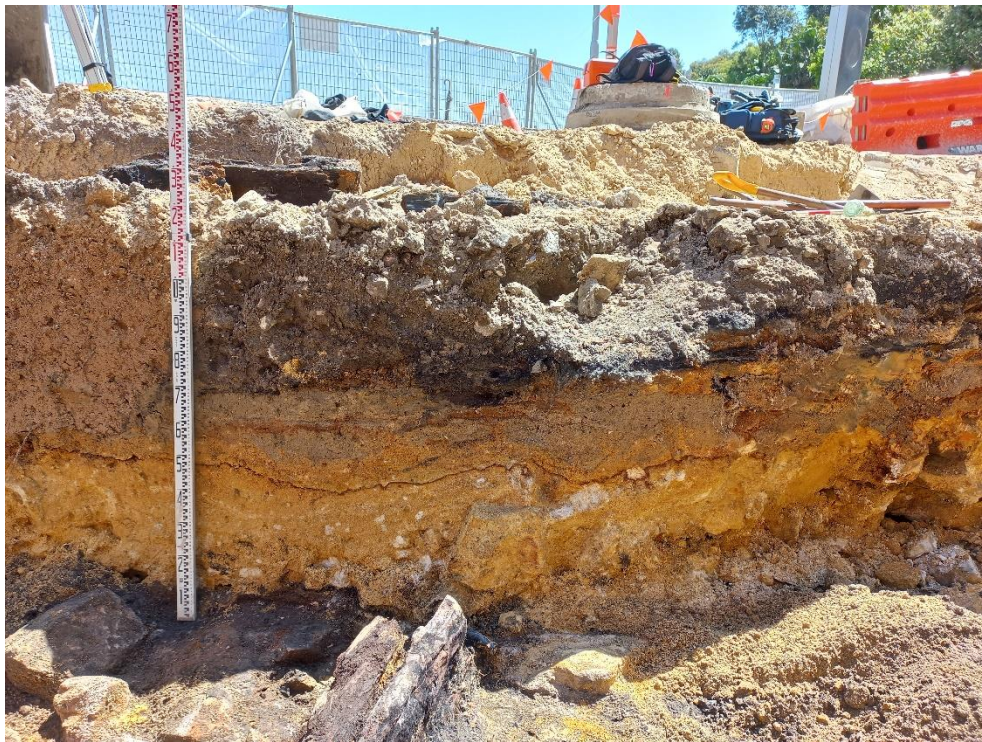
Figure 4.52: Bulk crushed sandstone fill in the east-facing section of Trench 5.2.
