Barangaroo Station COP Archaeological Excavation Report

Prepared by AMBS Ecology & Heritage
for BesixWatpac

June 2024

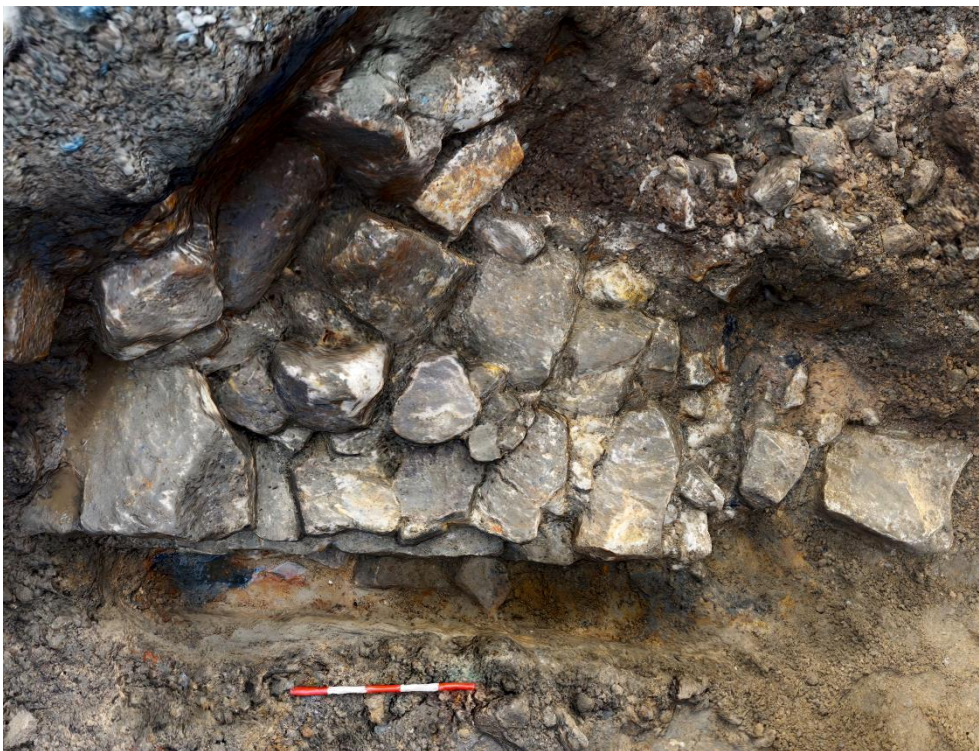
Figure 4.55: Orthophoto of the remains of the dock wall in Trench 5.3. Scale 500mm.

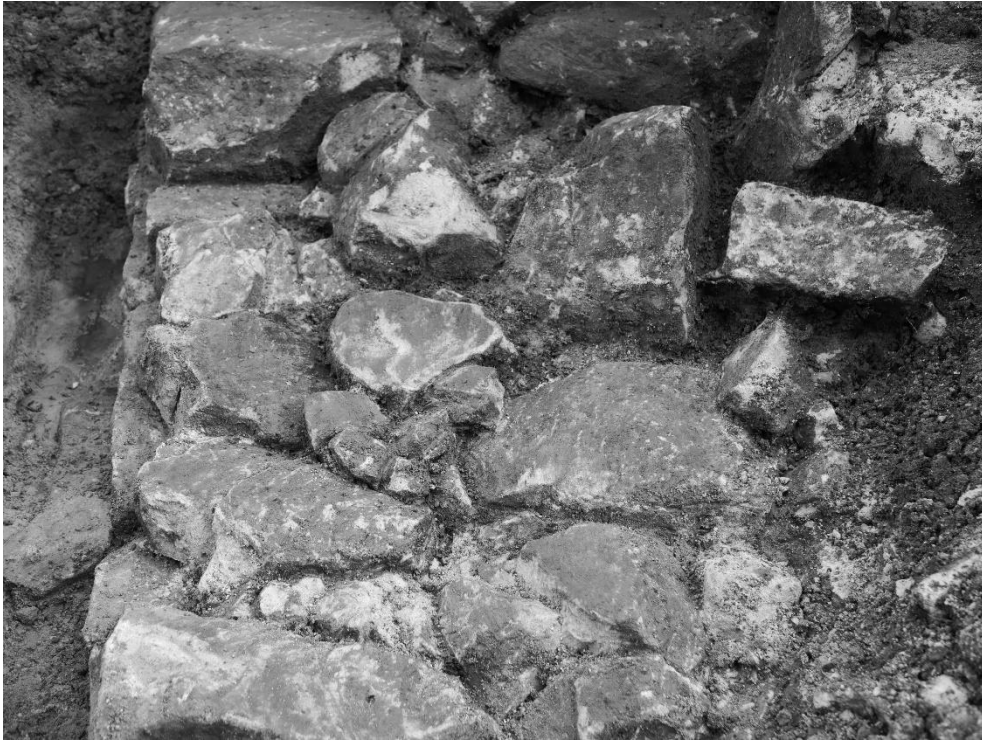
Figure 4.58: Detail of the wall 225 showing the larger blocks laid roughly in two rows with smaller rubble packing between. View to the west along the line of the wall.

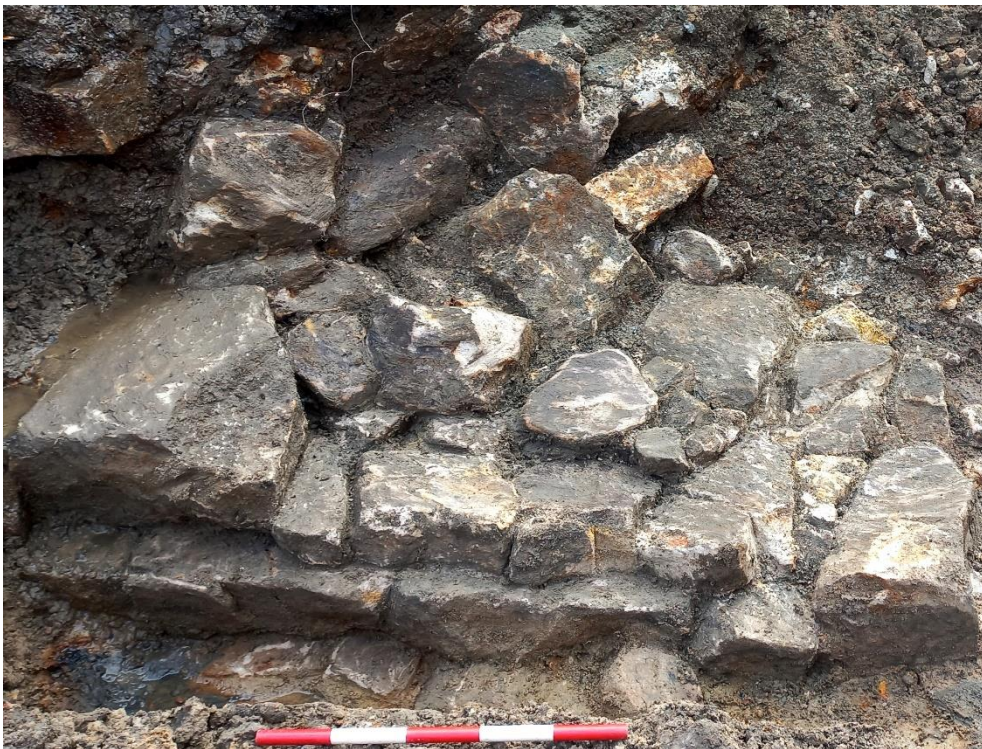
Figure 4.59: Exterior face of the wall showing considerable damage to the upper course. Scale 1m. View to the north.

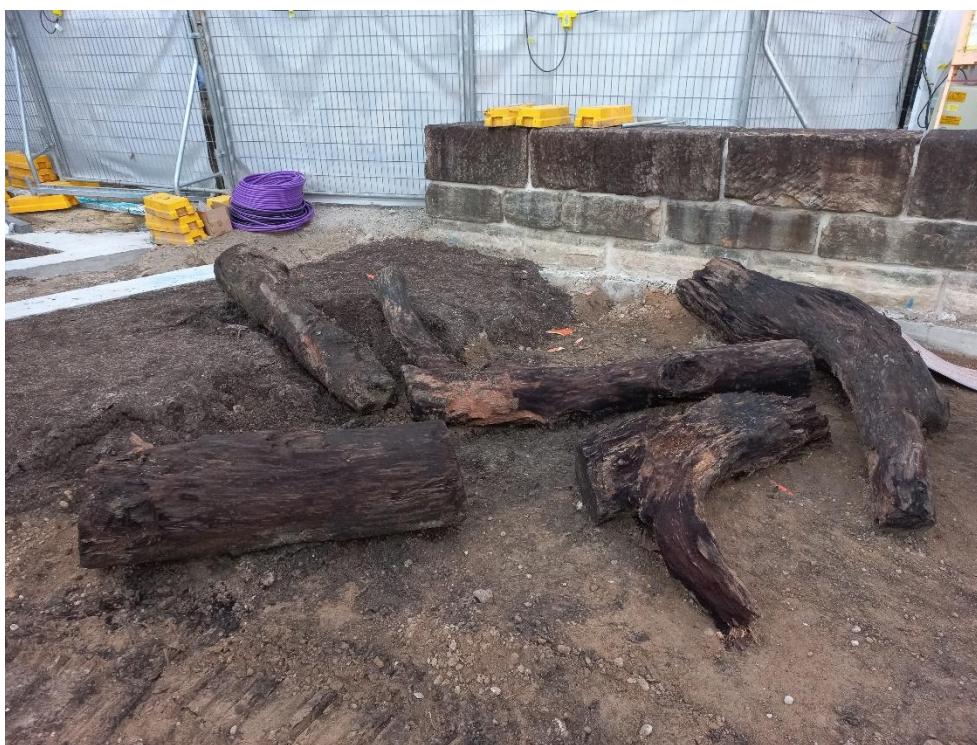
Figure 4.61: Ships' knees found within Trench 5.3.

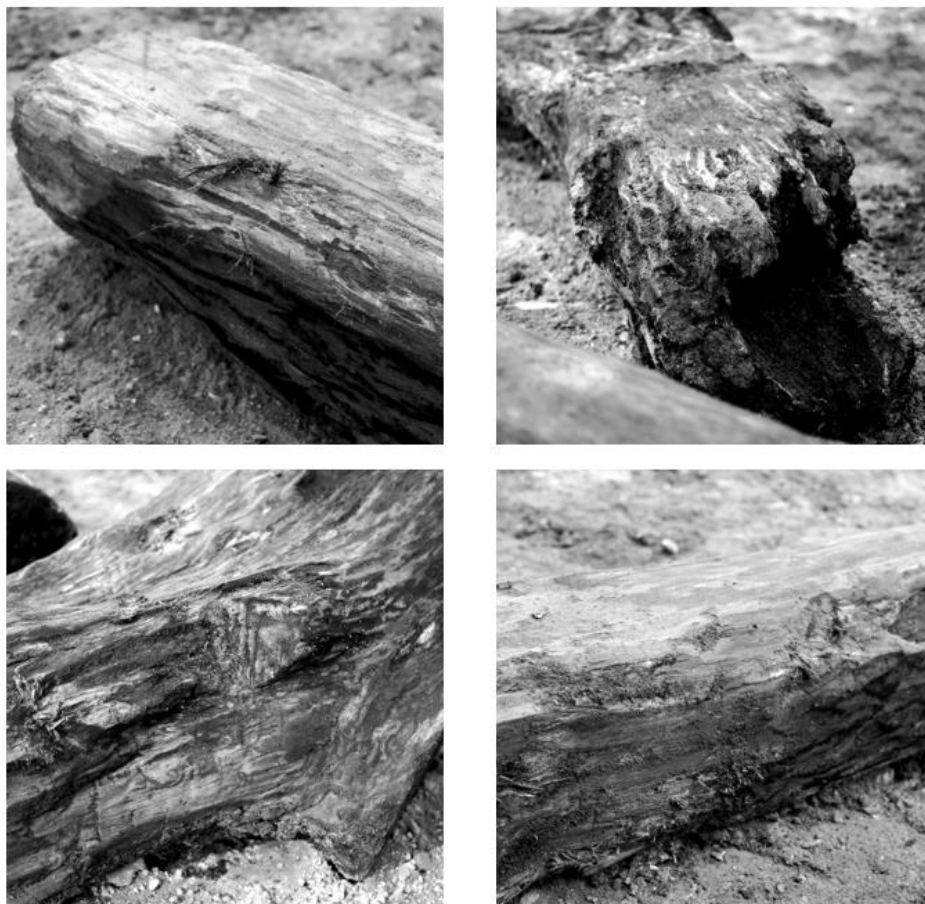
Figure 4.64: Details of the timber knees showing rough shaping and tool marks. Clockwise from top left: 228.5, 228.2, 228.5, 228.3.

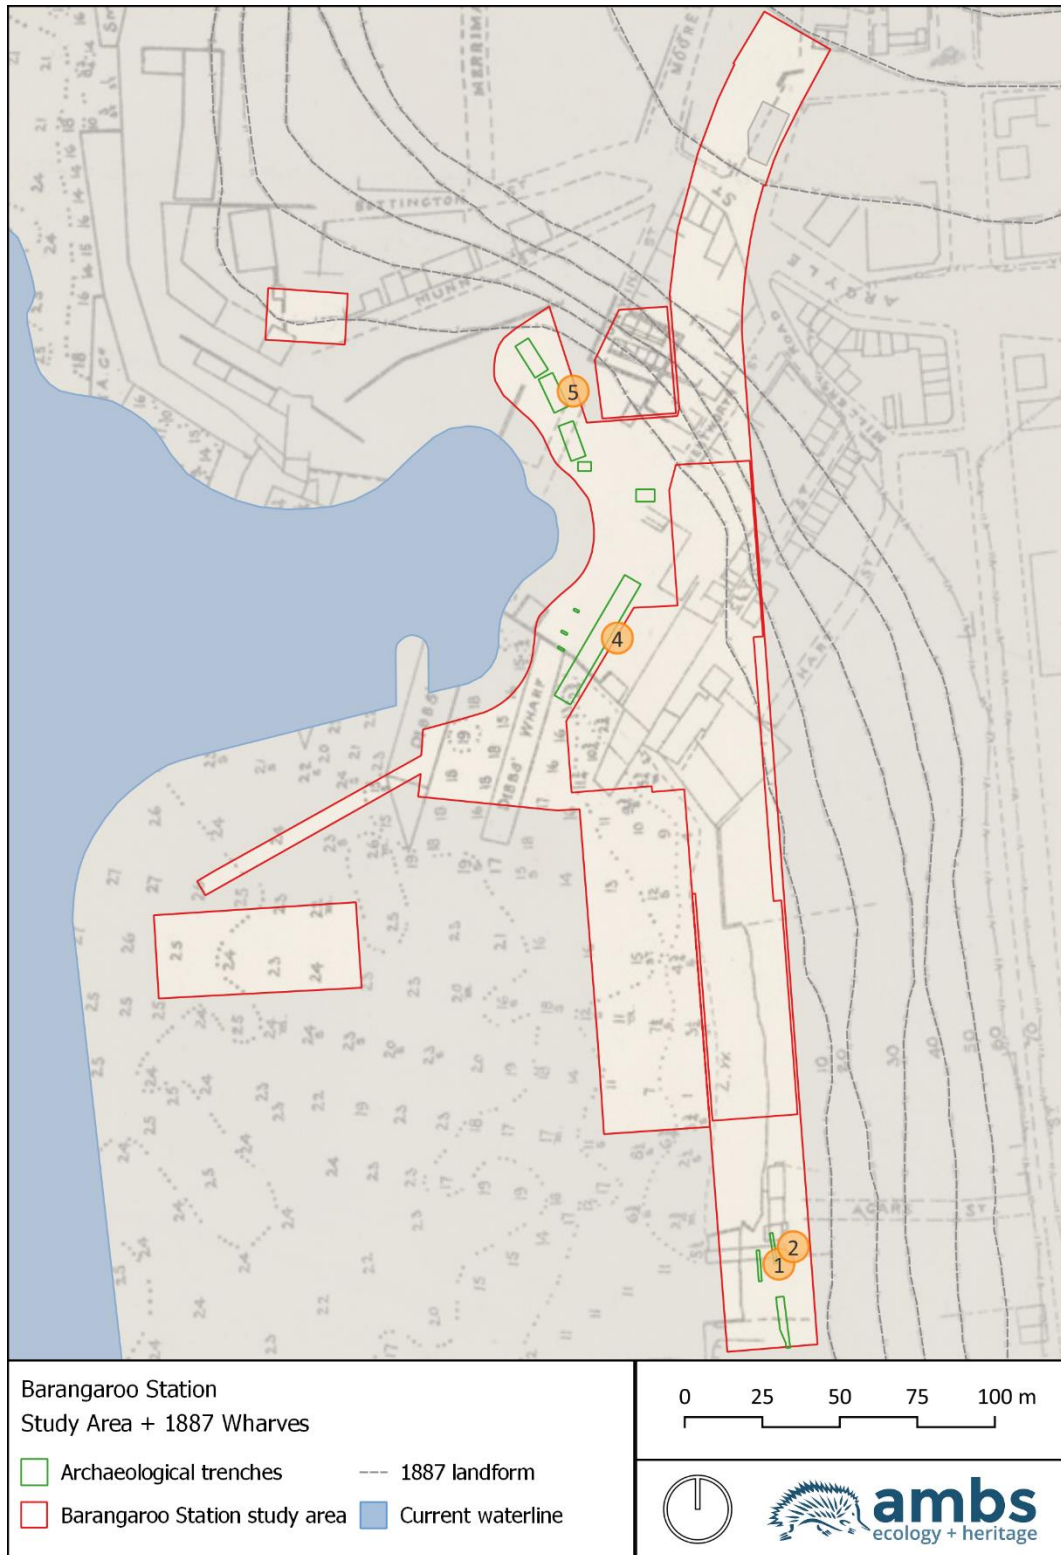
The study area is located within and to the west of Hickson Road, Barangaroo, within the City of Sydney Local Government Area (LGA) (**Figure 0.2**). The study area includes part of Lot 100 DP838323, part of Lot 52 DP 1213772 and part of Hickson Road. The study area is bounded in the west by the Hickson Road retaining wall and cutting. Artefacts were recovered from four locations (Trenches 1, 2, 4 and 5).

Figure 0.2: The Barangaroo COP study area, shown with trench locations discussed in this report and an 1887 plan of the wharves.

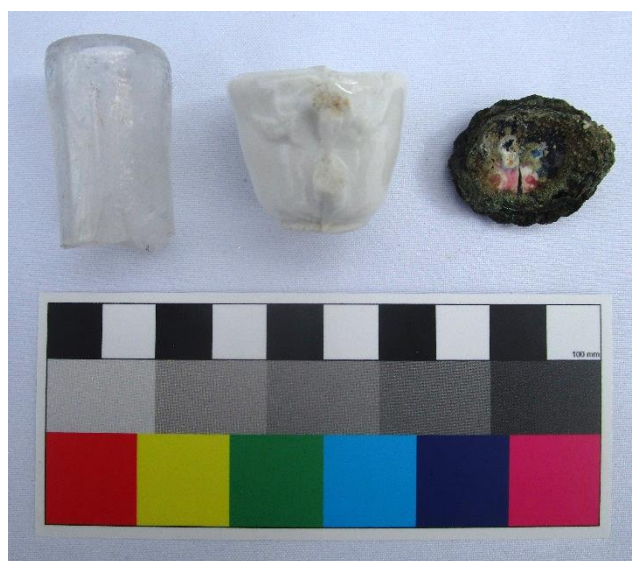
A number of individual items within fill [003] point toward the material having originated as domestic rubbish. These include a lady's enamel brooch with a delicate, twisted copper alloy wire frame (#272), a miniature teacup from a child's tea set (#270), and the finish of a colourless glass perfume bottle (#019; Figure 0.4). Three terracotta plant pots are also indicative of a domestic origin (#101, #102 & #103). A single large, 383mm long hand forged ferric pin is typical of those used to secure timbers in wharfage construction, and suggests that at least some of fill [003] was sourced from nearby, probably opportunistically (#300; Figure 0.5).

Figure 0.4: selected domestic items from fill [003]. Left: perfume bottle finish #019; middle: toy teacup #270; right: brooch #272. Scale 10cm. S Kuiters.

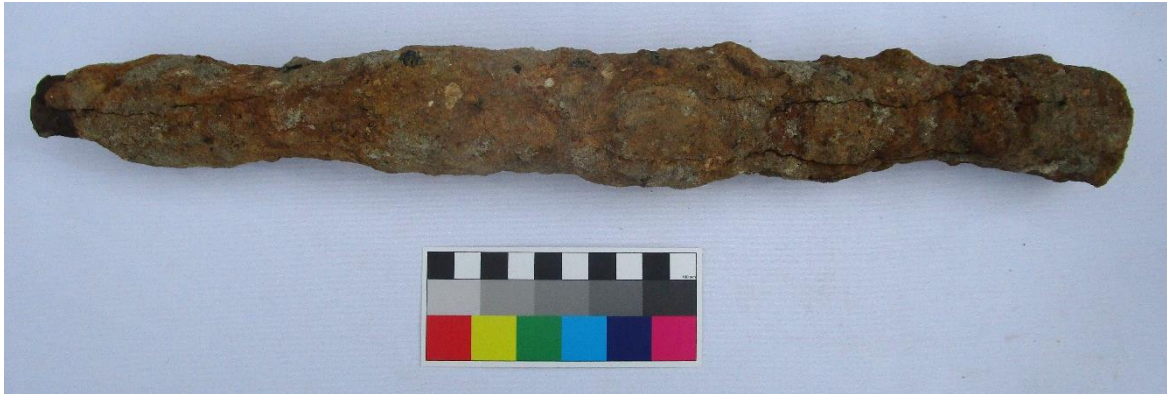
Figure 0.5: Ferric wharf pin (#300/[003]). Scale 10cm. S Kuiters.

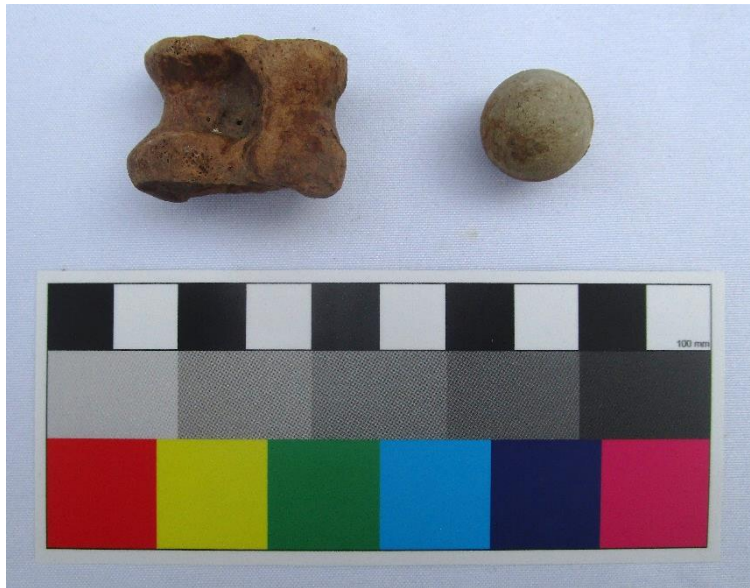
A ceramic marble and sheep's knucklebone (astragalus), are also notable within the [109] assemblage. The sheep knucklebone may have a recreational function beyond the original use of the animal for consumption (#380; Figure 0.8). Sheep's knucklebones were sometimes used as dice, and were also used in the children's game of knucklebones. Knucklebones is an ancient game of throwing and catching small objects known as jacks. It has been played throughout the world for millennia. In colonial Australia, the knucklebones of sheep were the most common type of jack until the mid-20th century (The Game of 'Knucklebones' in the Dorothy Howard Collection. 2023). The fine earthenware marble may also suggest the presence of children spending time at the wharf (#290; Figure 0.8). Wharf labourers often waited for hours at the wharf for a job (Mitchell 1973: 12). Perhaps the young workers passed the time waiting for work with games of marbles and jacks, however, it is just as likely that the small objects washed down from the houses above.

Figure 0.8: Artefacts associated with recreational games. Left: sheep knucklebone (#380/[109]); right: marble (#290/[109]). Scale 10cm. S Kuiters.

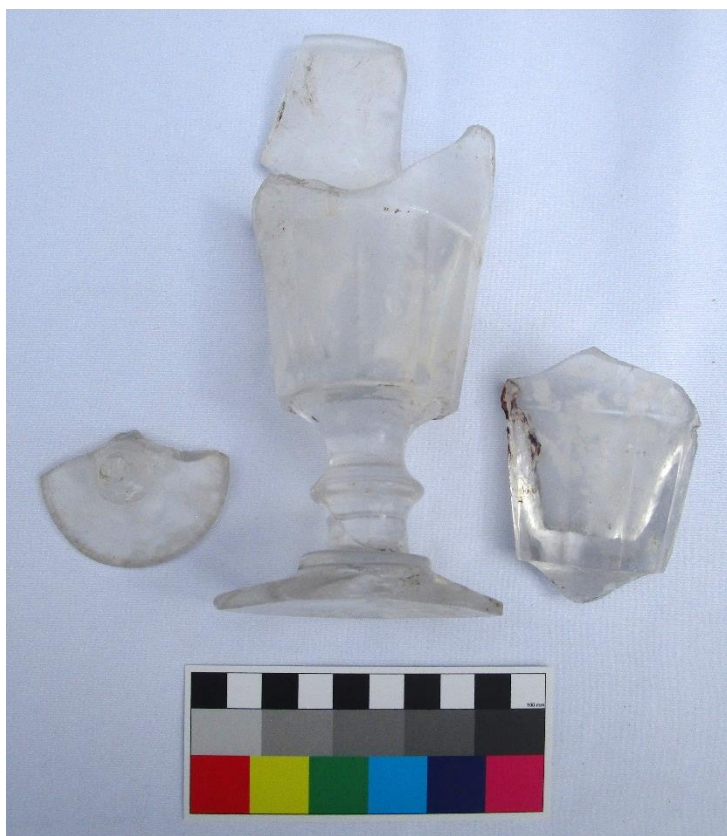
Like context [109], it is likely that many of the artefacts within surface [107] were dumped or washed down from houses along Wentworth, Clyde, Unwin and Munn Streets, which were situated on a steep and rocky slope above the wharf. Some of the uniquely domestic items recovered from surface [107] include two stemware glasses (#065 & #06; **Figure 0.10**), a milk glass vase (#068), a bone china egg cup (#200) and two wash basins (#198 & #170). Eight teacups, four saucers, one Chinese porcelain coffee can (#204) and a Rockingham glazed teapot (#199), were also identified. Several items stand out as being too large to have washed down to the wharf surface via a drain or storm event. For example, a blue transfer print wash basin is 50% complete (#170) and three plates are each 30% complete (#175, #176 & #181). These were probably dumped directly at the wharf site by the residents of nearby houses.

Figure 0.10: Stemware glasses from context [107]. Left: #066; right: #065. Scale 10cm. S Kuiters.

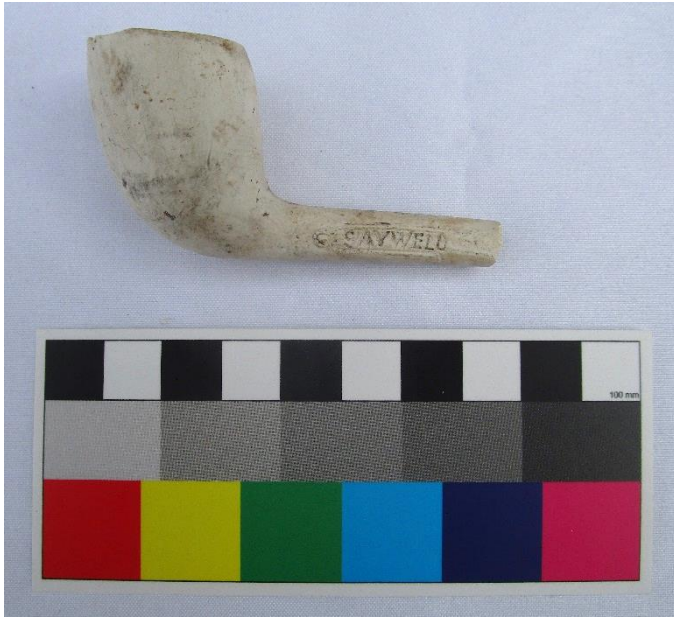
At least some of the artefacts recovered from the surface, however, would have been deposited or lost by workers at the wharf. Any of the five smoking pipes recovered from context [107] may have belonged to wharf labourers. Of particular note is one burnt and snapped pipe which has been ground at the broken end to create a new mouthpiece (#273; **Figure 0.11**). The stem is embossed with 'SAYWELL' and 'SYDNEY', and was made in the United Kingdom for tobacconist Thomas Saywell, who had a shop in Sydney from 1863 to 1905 (Geeves 2006). Another pipe stem is embossed 'DAVIDSON', and 'GLA[SGOW]', and was manufactured by Thomas Davidson of Glasgow between c.1861 and c.1891 (#275) (Clay Pipe - Ceramic, Thomas Davidson, Glasgow, circa 1861-circa 1891. 2023). A slate pencil may also have been used in work-related activities at the wharf (#278).

Figure 0.11: Pipe reading 'SAYWELL' on left hand side of stem (#273/[107]). Right hand side reads 'SYDNEY'. Scale 10cm. S Kuiters.

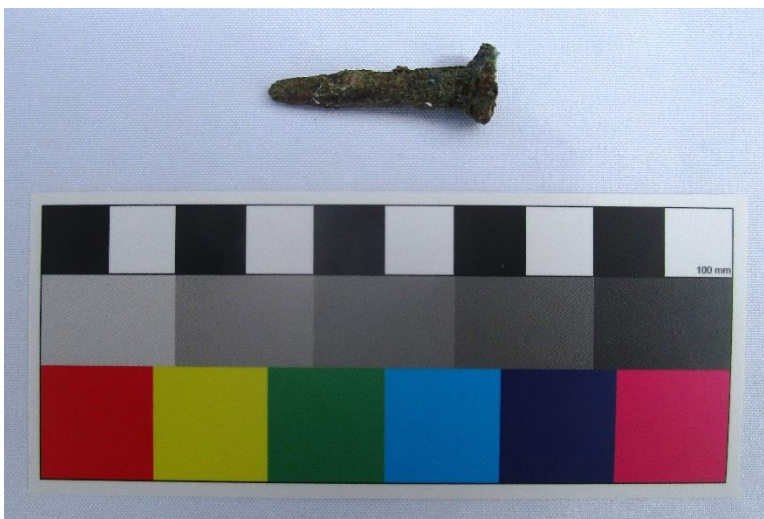
A single hand forged copper alloy sheathing nail recovered from surface [107] is the only artefact associated with ship building from the Barangaroo COP site (#303; Figure 0.12). Copper sheathing was fixed to the hulls of ships below the waterline to prevent teredo worms (*Teredo navalis*) from boring into the wood as early as the late 18th century, and was common practice by the early 19th century (Staniforth 1985).

Figure 0.12: Sheathing nail (#303/[107]). Scale 10cm. S Kuiters.

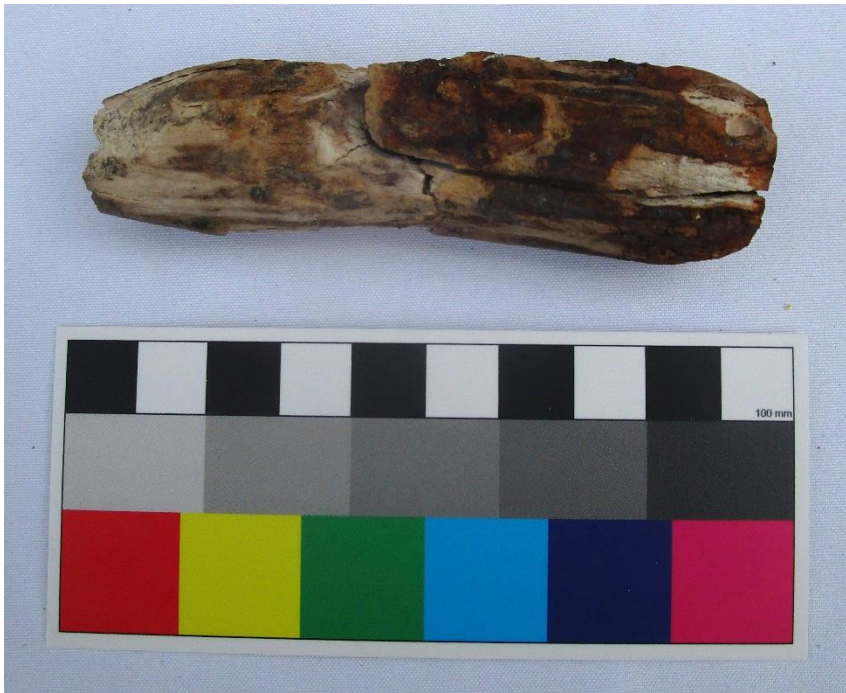
Finally, a whale tooth mounted on a missing ferric base speaks to the maritime links of the workers and/or residents of Millers Point (#288; Figure 0.13). The tooth, probably from a sperm whale, was 88mm in length and does not display evidence of scrimshaw. It may have been collected as an ornamental curio, or it may have been intended for scrimshaw but lost before carving began.

Figure 0.13: Whale tooth (#288/[107]). Scale 10cm. S Kuiters.

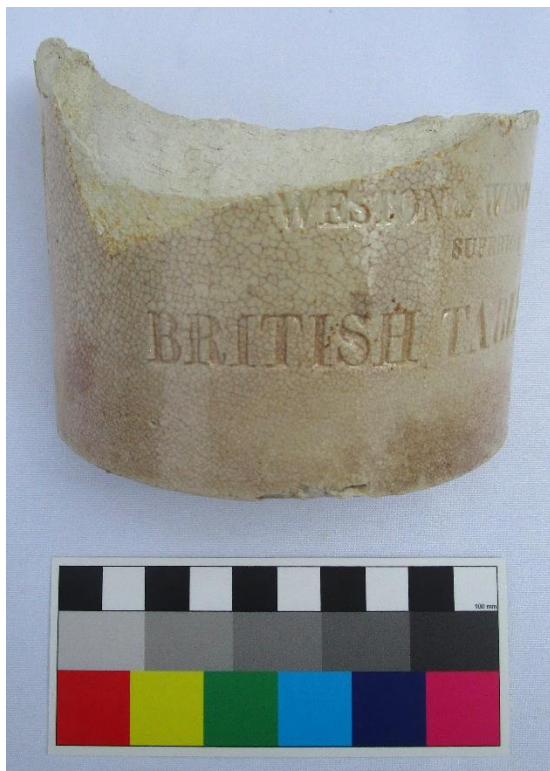
The latest terminus post quem for context [214] is a fragment of sandstock brick loosely dated to c.1850 to c.1900 (#314). However, it is important to note that this date range is a broad approximation only, and based on generalities related to style and method of manufacture. A more suitable terminus post quem for context [214] relates to a fine earthenware salt jar, the body of which is impressed: 'WESTON & WESTALL'S / SUPERIOR / BRITISH TABLES[ALT]' (#231; Figure 4.47). Weston & Westall were listed as a salt merchants located at 115 Lower Thames Street in the 1843 London Street Directory (London Street Directory in 1843 - W11. 1843), whereas Weston, F.D. was listed at the same address in the 1820 Post Office London Directory (The Post office London directory. 21st ed. (1820). 1820: 376). A specific start date for Weston & Westall Salt cannot be found at the time of writing, but must be sometime between c.1820 and c.1843. A light green cup bottom mould glass bottle (#093) and white granite ceramic teacup (#222) also broadly date from c.1840 onwards, suggesting that fill [214] was deposited sometime in the late 1840s or 1850s.

Figure 0.14: Weston & Westall's salt jar (#231/[214]). Scale 10cm. S Kuiters.

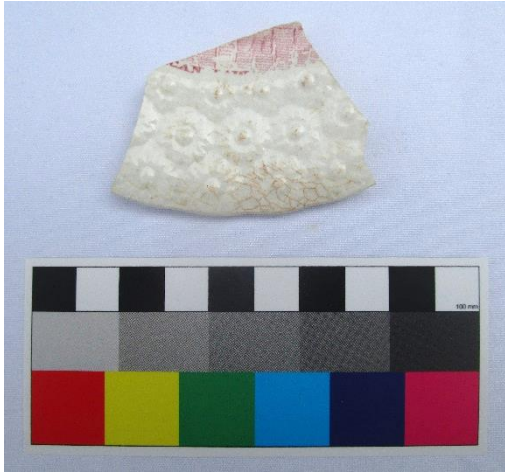
Twenty-four out of the twenty-eight items for which a general function can be identified are associated with food or beverages (Table 0.10). These include a fragment of a red transfer print fine earthenware child's plate (#227; Figure 4.48), and part of a press moulded glass tumbler (#094). Other items include a blacking bottle (#232), and penny ink bottle (#234), both made from salt glaze stoneware. All of these items are commonly encountered on 19th century sites in Sydney, but are more typical of domestic deposits rather than industrial or worksite deposits.

Figure 0.16: Child's plate (#227/[214]). Scale 10cm. S Kuiters.
