Report on  
Preliminary Site Investigation (Contamination)

Barangaroo Station Construct Only Package  
Hickson Road, Barangaroo

Prepared for  
Watpac Construction Pty Ltd

Project 209150.00  
November 2021

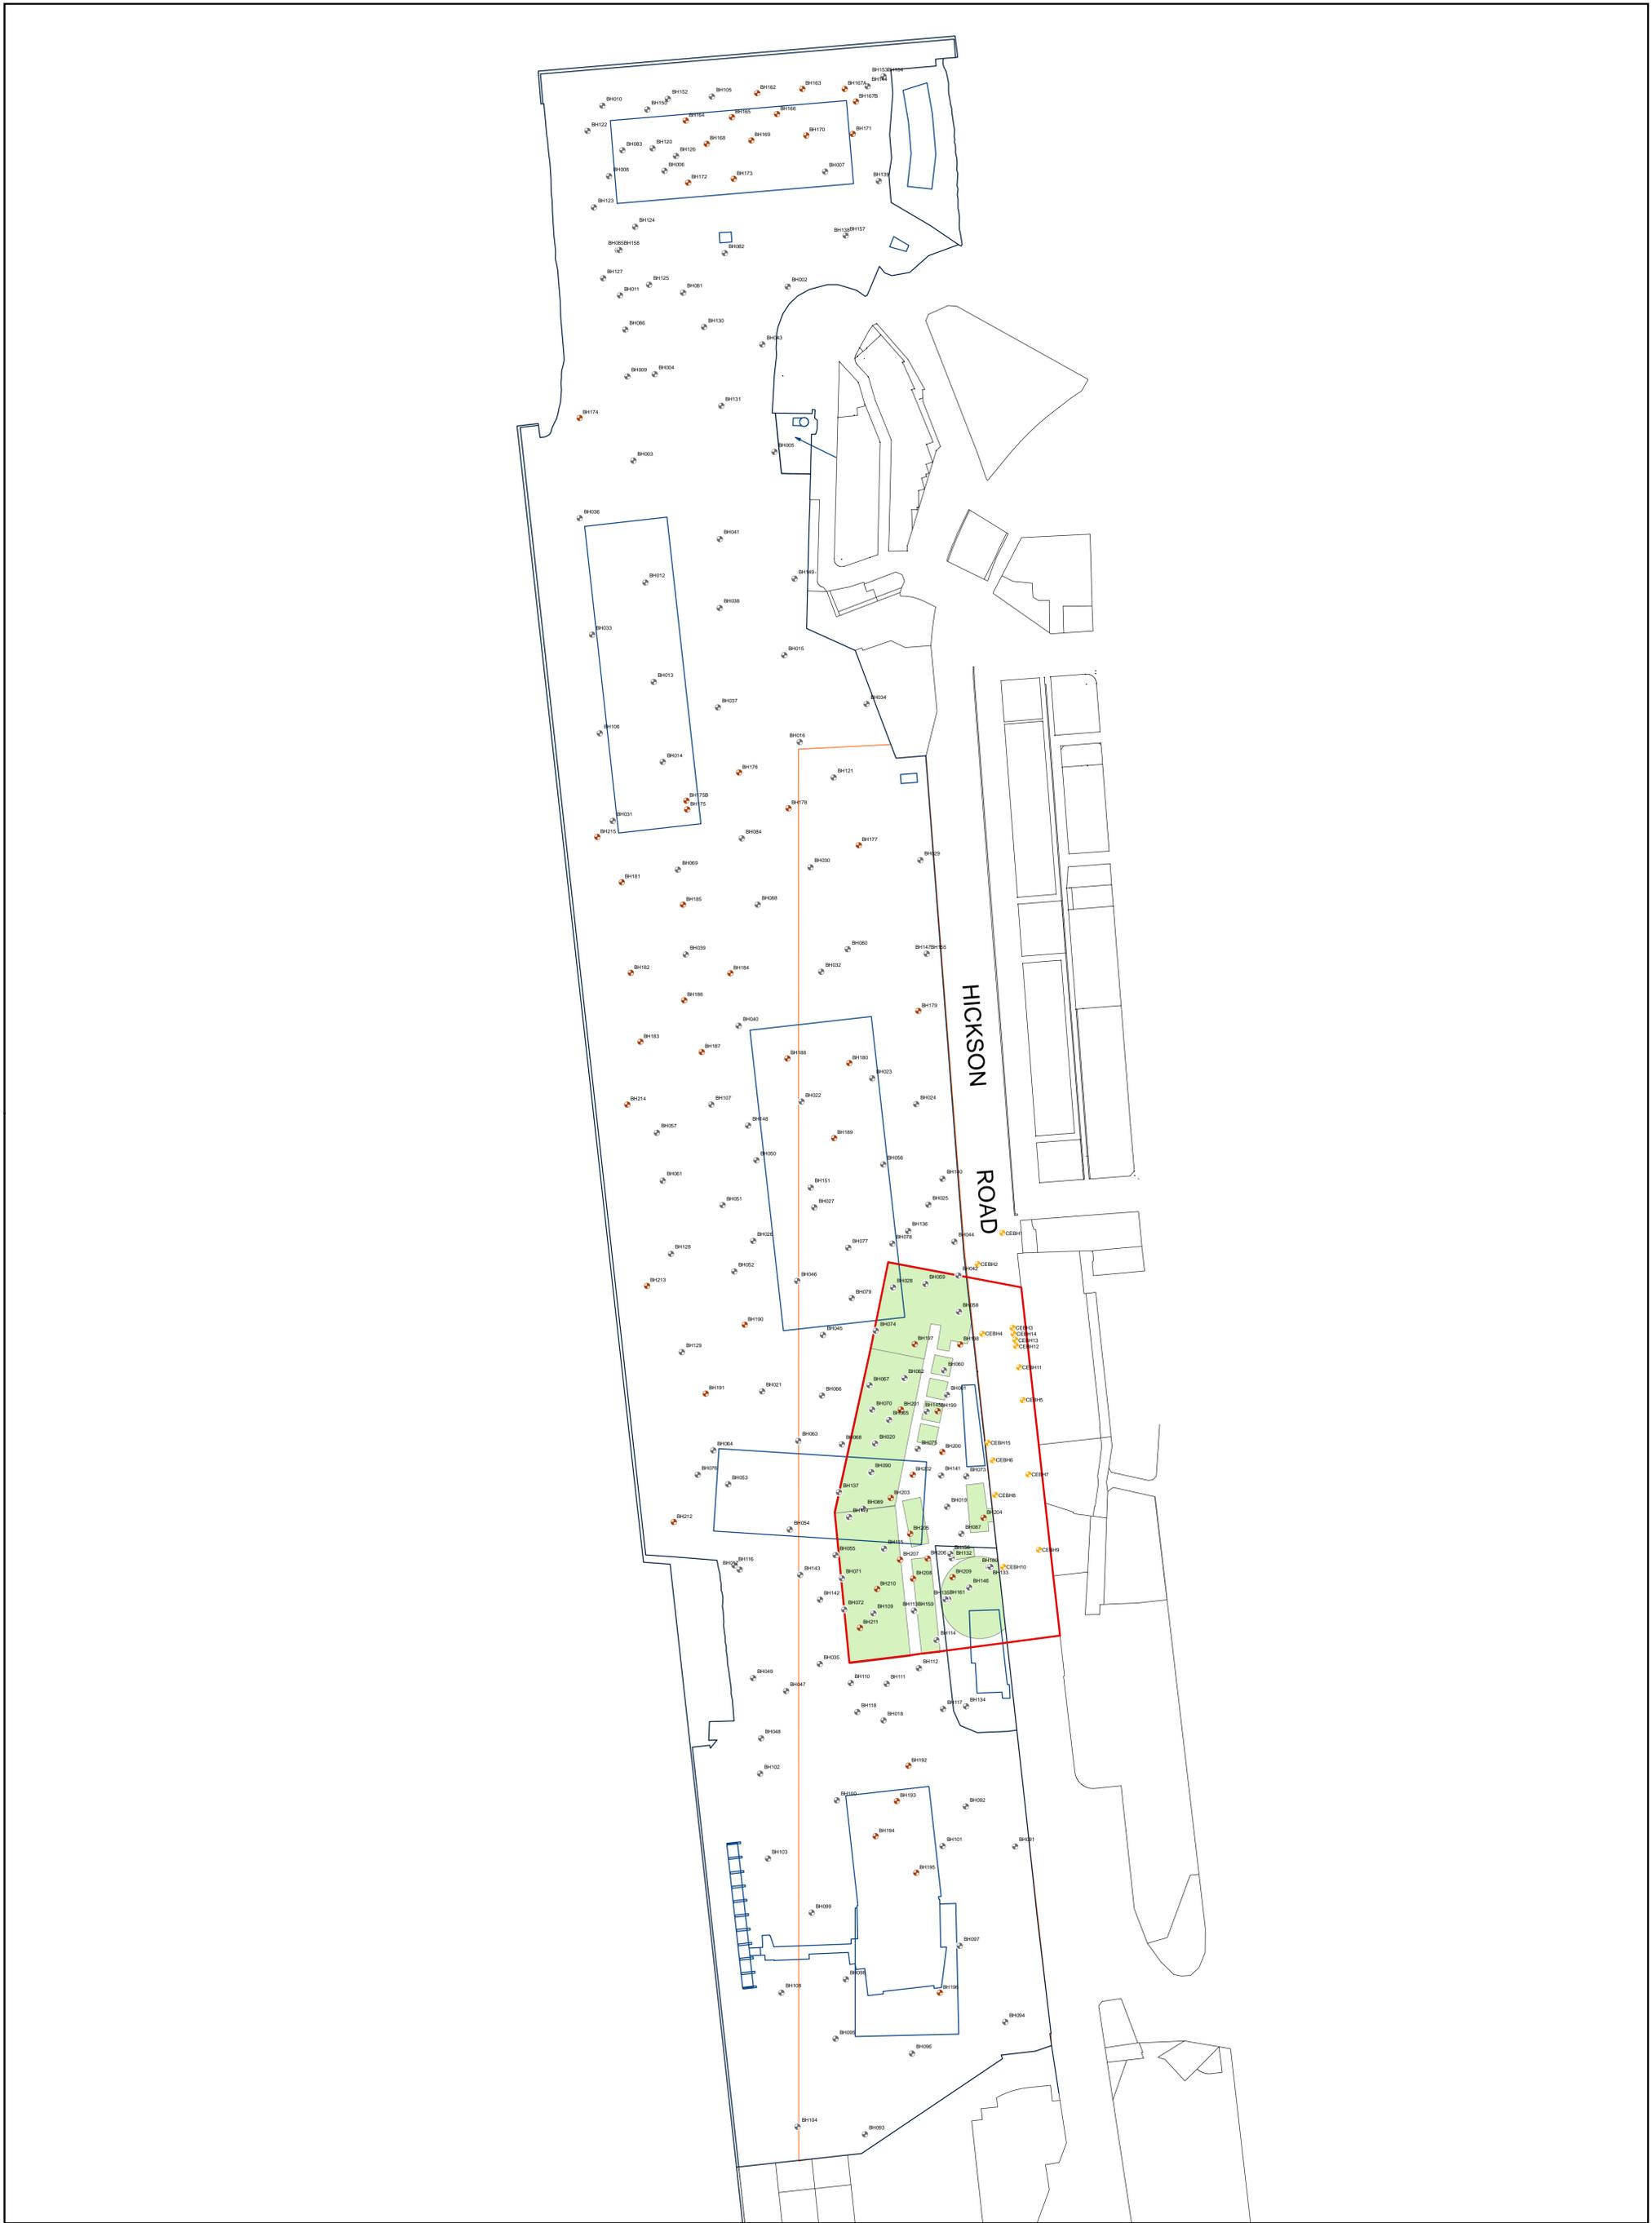
A total of 153 soil bores were drilled across the investigation area in mid-2006. Groundwater wells were installed at 24 locations. A relatively higher sampling density was adopted for the former gasworks. It appears that soil bores BH029 and BH034 were drilled within the subject site and numerous bores were drilled in close proximity to the subject site. The borehole locations are included in Figure 4 from ERM (2010), provided in Appendix A of this PSI.

It is noted by DP that BH177 appears to have been drilled at the subject site. The borehole locations are included in Figure 4 from ERM (2010), as provided in Appendix A of this PSI.

ERM (2010) makes reference to Coffey Environments Pty Ltd (Coffey), *Preliminary Environmental Investigation*, 2008 which has not been sighted by DP. It is noted that bore CEBH1 was positioned at the south of the subject site. The borehole locations are included in Figure 4 from ERM (2010), provided in Appendix A of this PSI. No data or borehole logs from Coffey's investigation were presented in ERM (2010).
