Barangaroo Station

# Heritage Management Sub Plan

N217  
BR COP  
28 February 2023

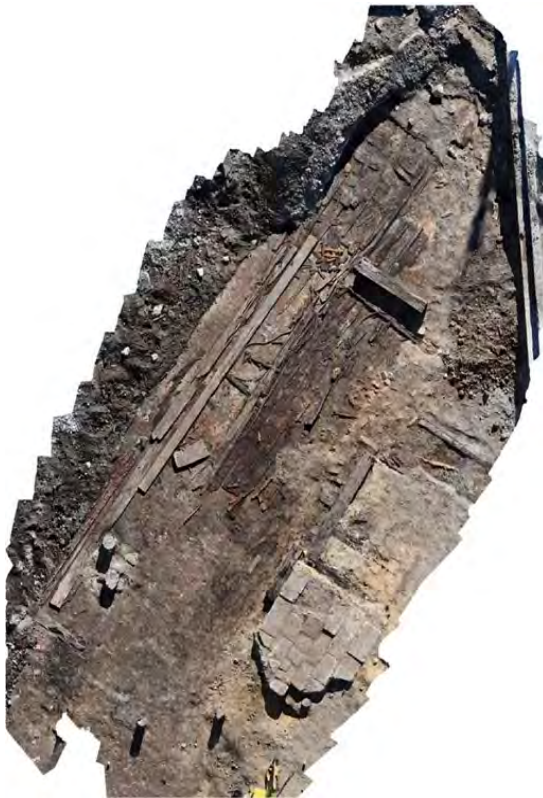
**Figure 3.4: Orthophoto of Area T showing timber debris on Cuthbert's Wharf (Casey & Lowe, 2019, p. 18)**

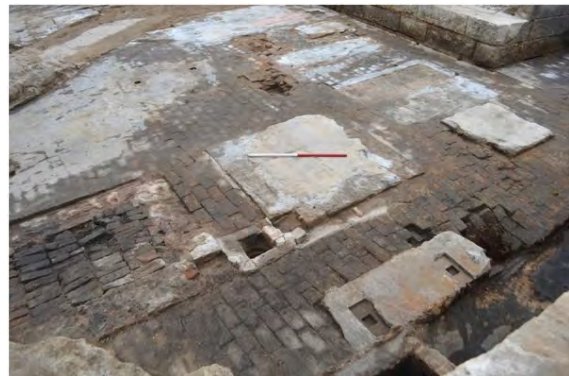
**Figure 3.6: Foundations and floors of late nineteenth century wharf structures, Area Z (Casey & Lowe, 2019, p. 43)**

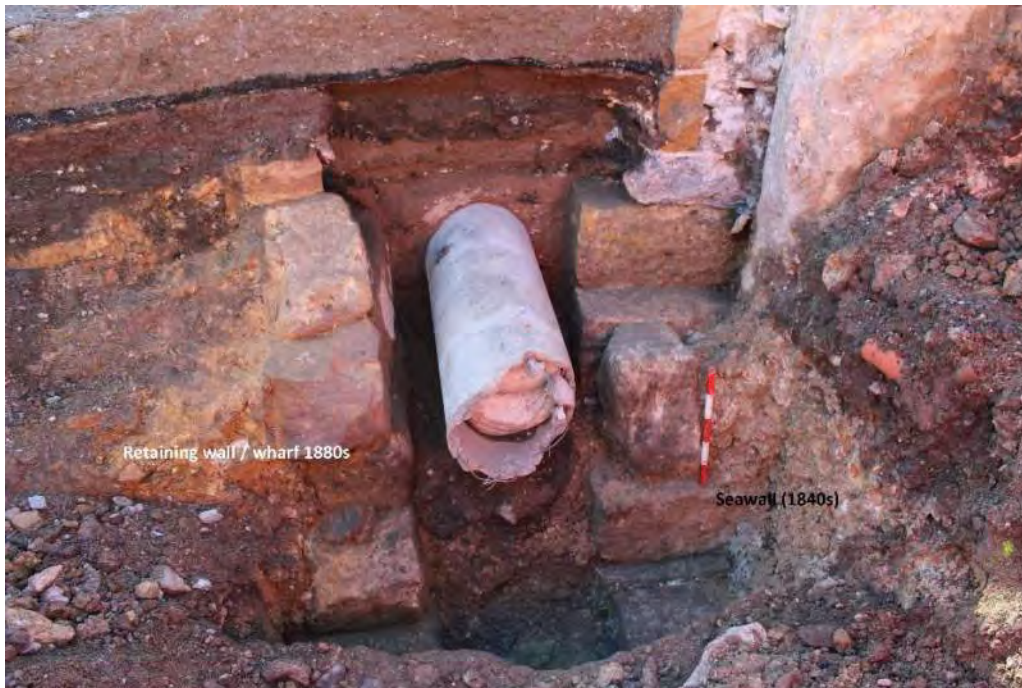
Photo 3 1840s seawall and 1880s retaining wall uncovered at Balmain East, 2016

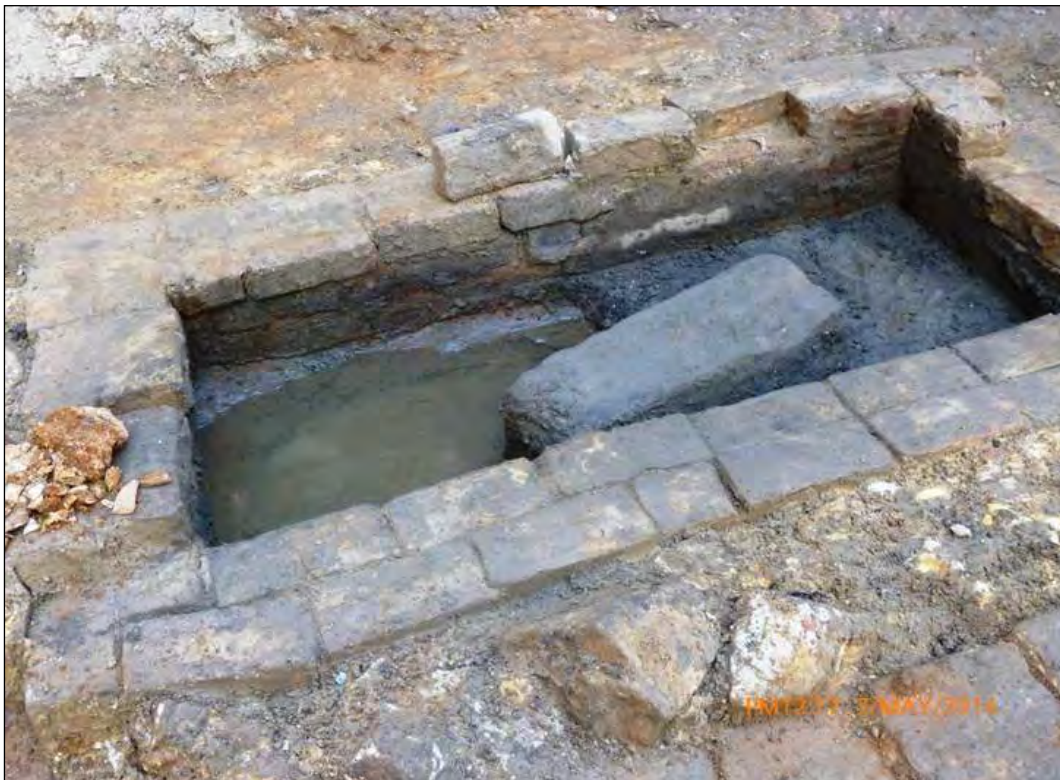
Photo 7 - Sandstone flagging and cesspit - Wynyard Walk project, 2014

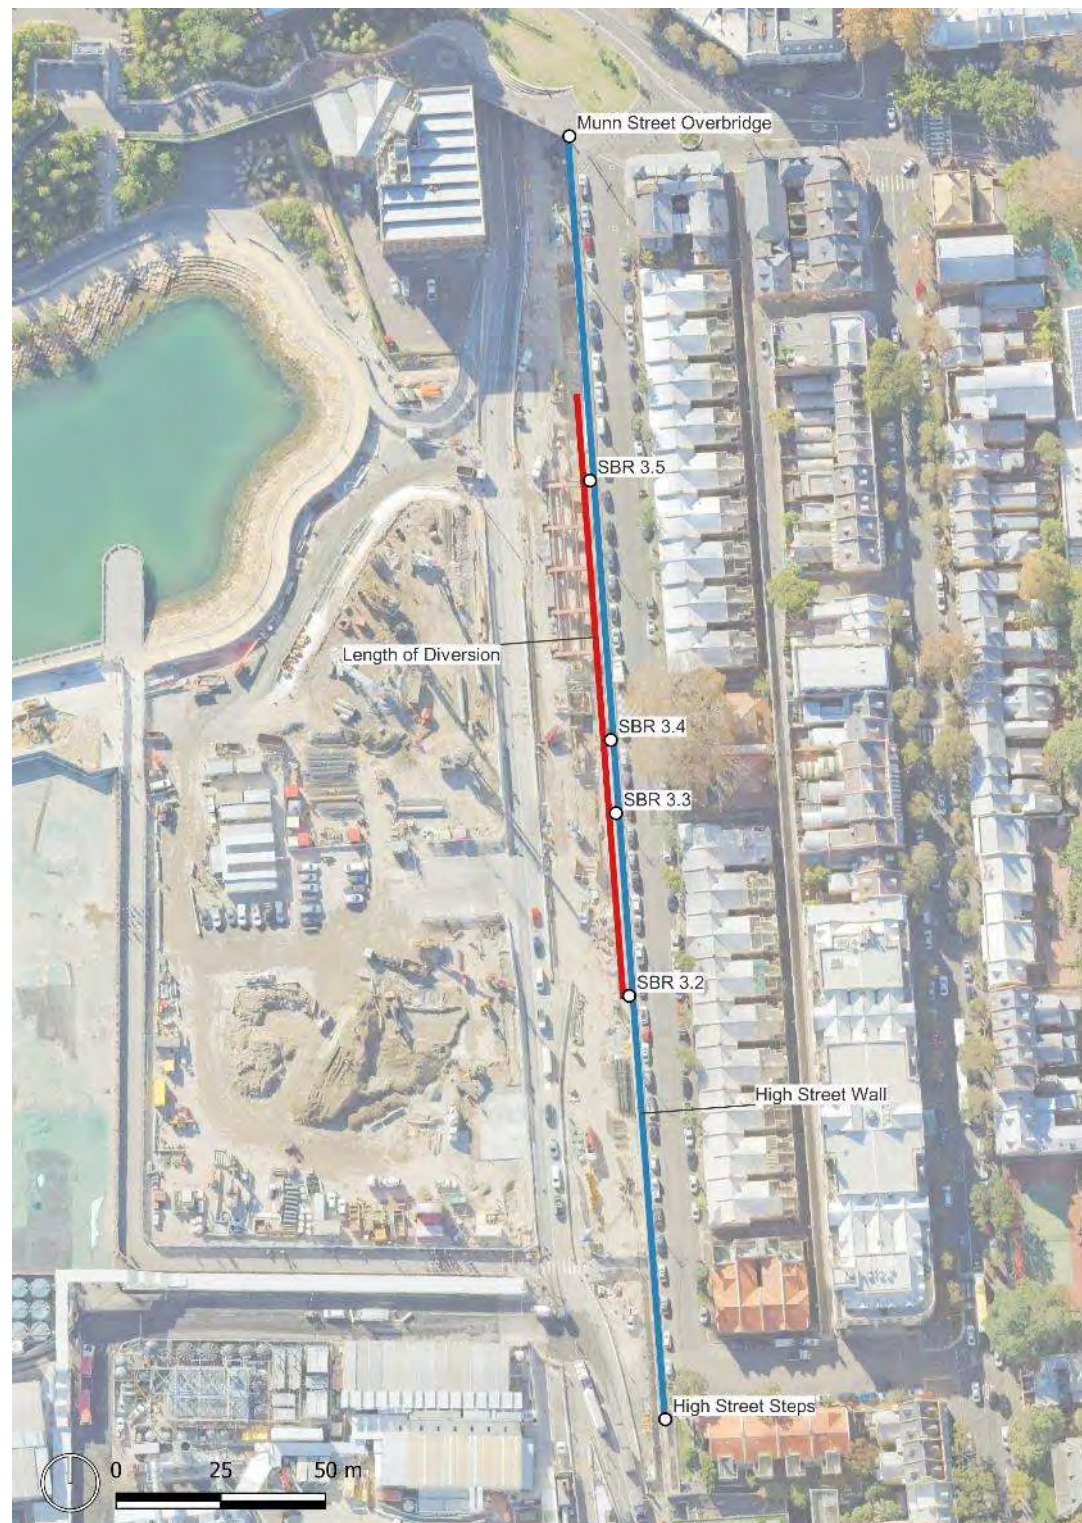
**Figure 1: Location of the High Street wall, downpipes (SBR) and length of the diversion.**

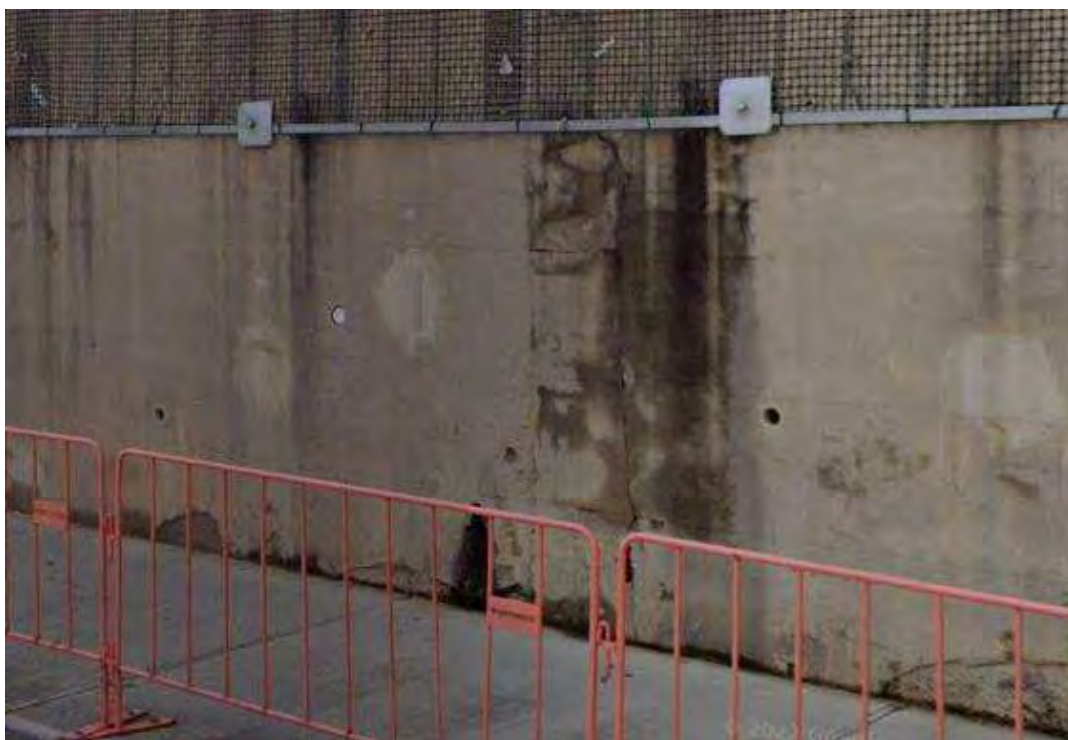
**Figure 7: Cracking at the location of SBR 3.2.**

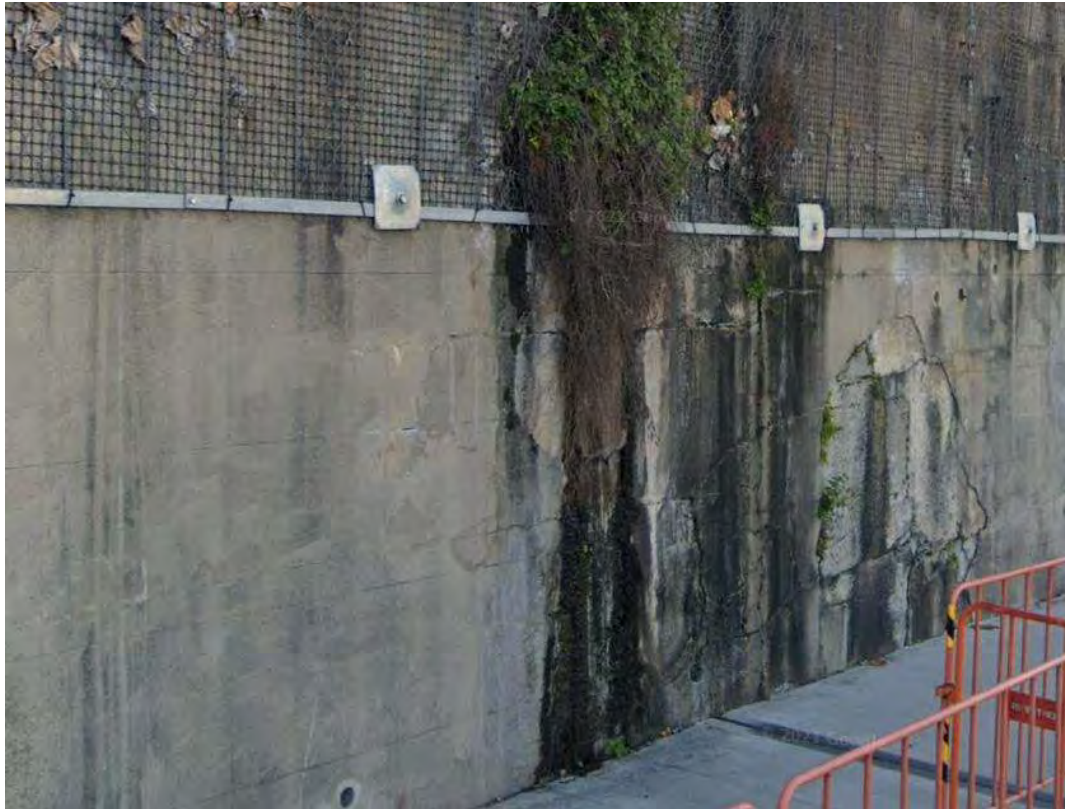
**Figure 9: Cracking and intrusive vegetation at the location of SBR 3.4.**

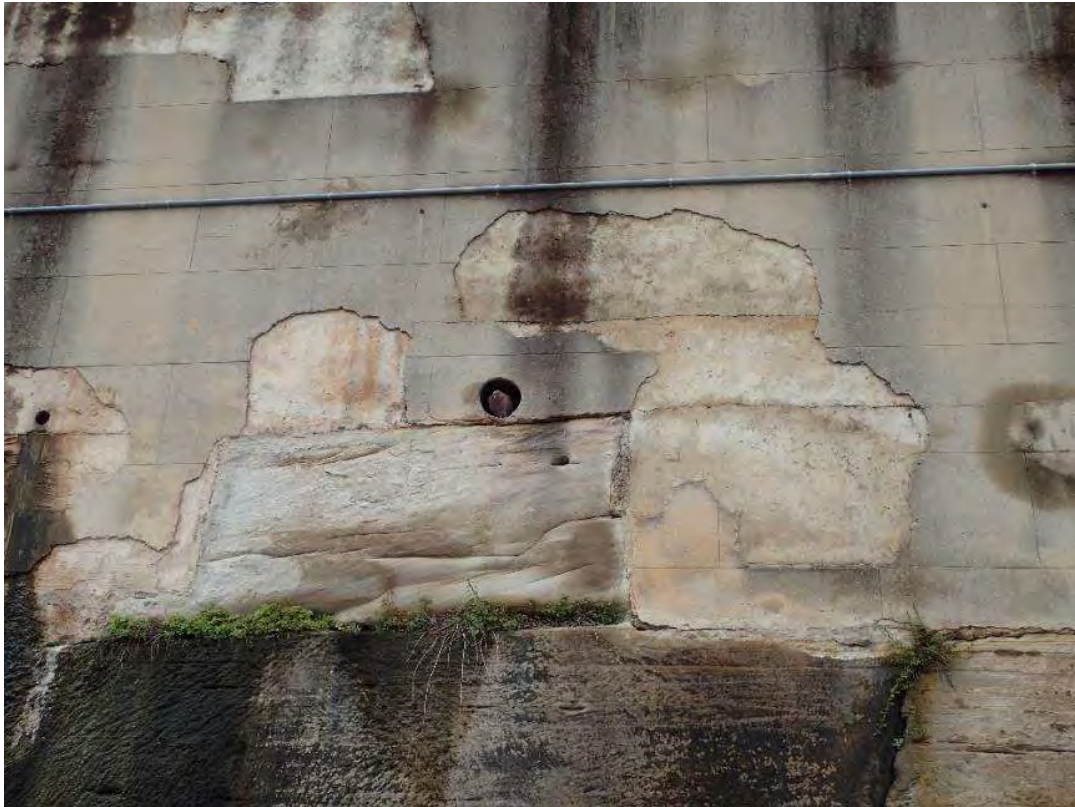
**Figure 11: A section of the cutting and wall. The render is scored to replicate masonry blocks and is aligned along the line of the natural bedrock, above which the underlying sandstone blocks have been exposed.**

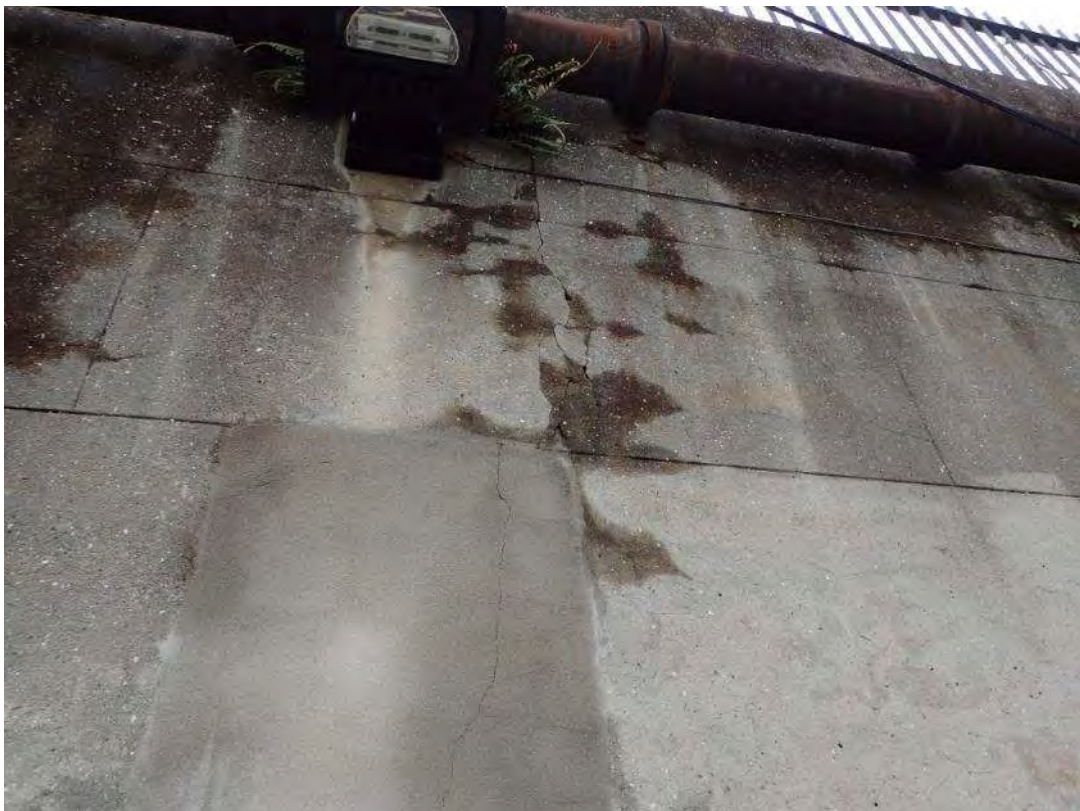
**Figure 12: A patch of modern cement render surrounded by the original render. The white flecks are shell fragments.**

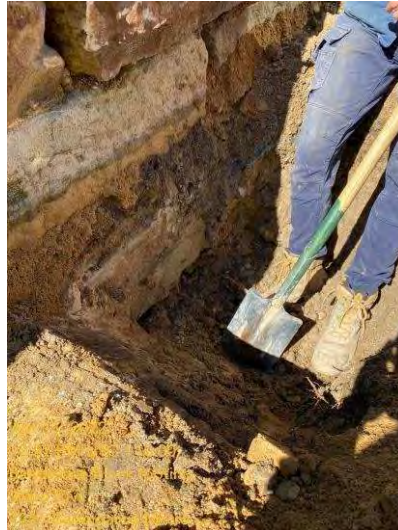
Figure 4: Concrete footing beneath sandstone blocks

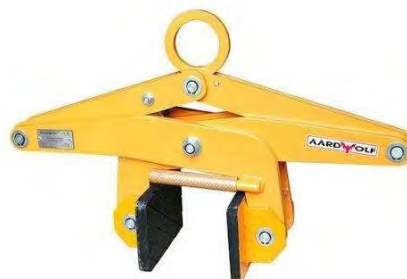
Figure 5: Rubber padded grab attachment

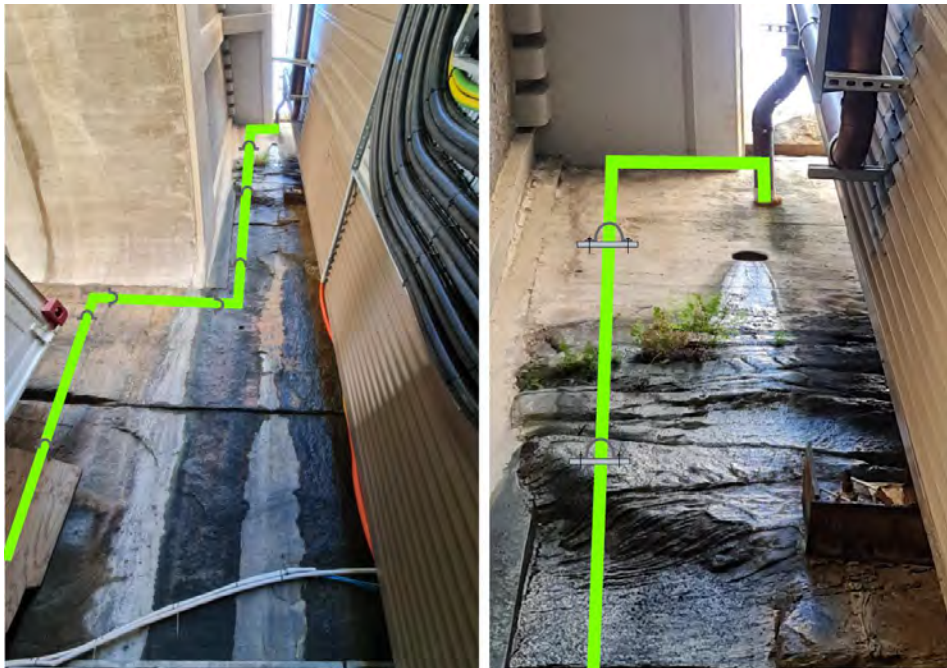
Figure 3: Illustration of the diversion.
